## Appendix I:

Detailed viewpoint assessment

# Hunter Transmission Project Landscape and visual impact assessment

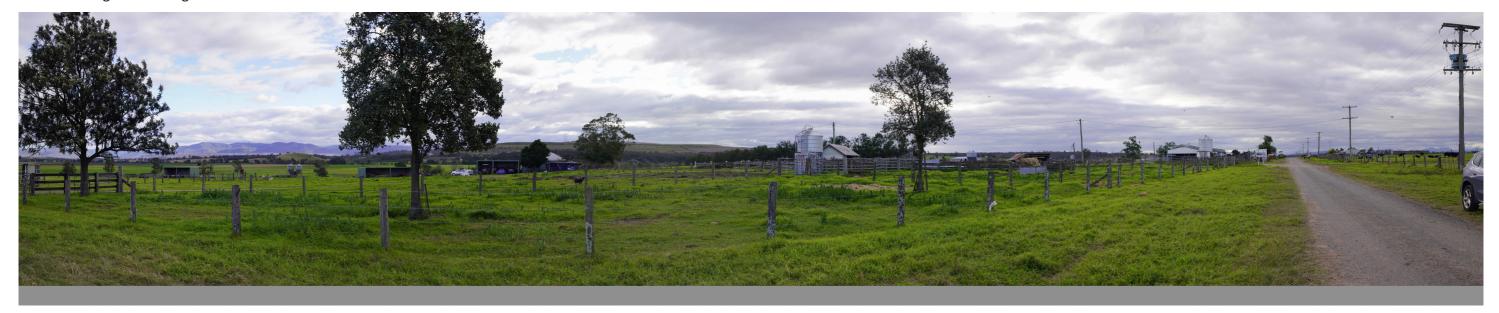
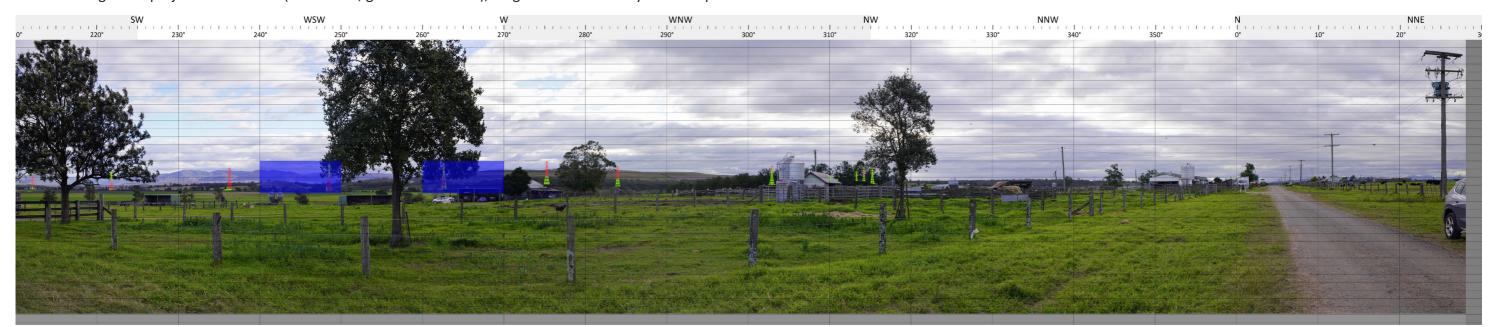
### HTP ID92: 50 Shearers Lane, Maison Dieu

Photomontage - including indicative transmission structure locations

Photomontage with project in silhouette (red in view, green out of view), magnitude tool overlay and occupied cell count

Distance to project	Viewpoint type	Viewpoint sensitivity	Scenic quality		Occupied cells	Magnitude rating	Impact rating
1339 metres	Primary view from rural dwelling	Moderate	Moderate	Moderate	8	Low	Low

View across cleared rural land on flat to gently undulating land on a bend in the Hunter River. There are scattered trees across the fields and in the vicinity of scattered rural dwellings. The view includes several farm sheds and fencing. The foreground landscape has an open, rural character.

In the middle ground is a view to mining land, including large constructed bunds that are in the process of being revegeted. There are no unique or prominent landscape features apart from distant views, beyond the mining areas, to vegetated and rural hills. While this road is located near to the Hunter River, the river is not visible given the flat terrain and distance.

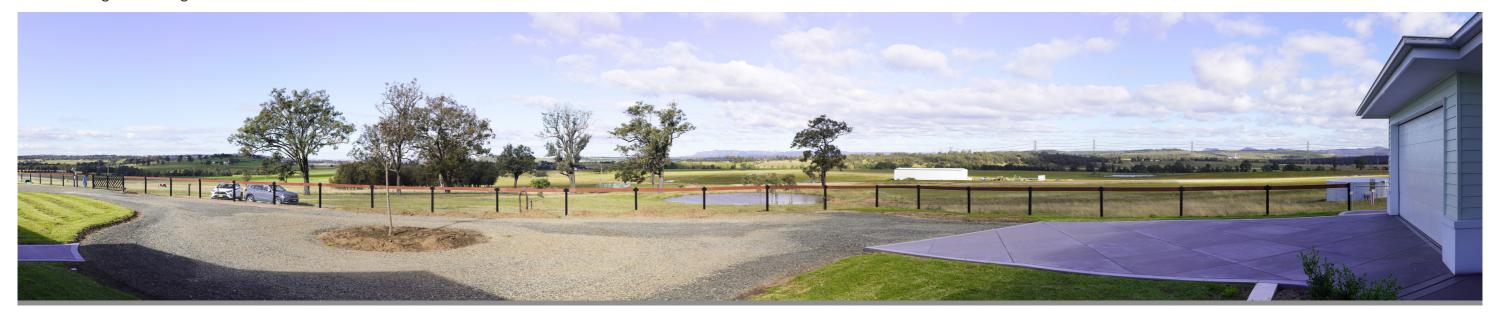
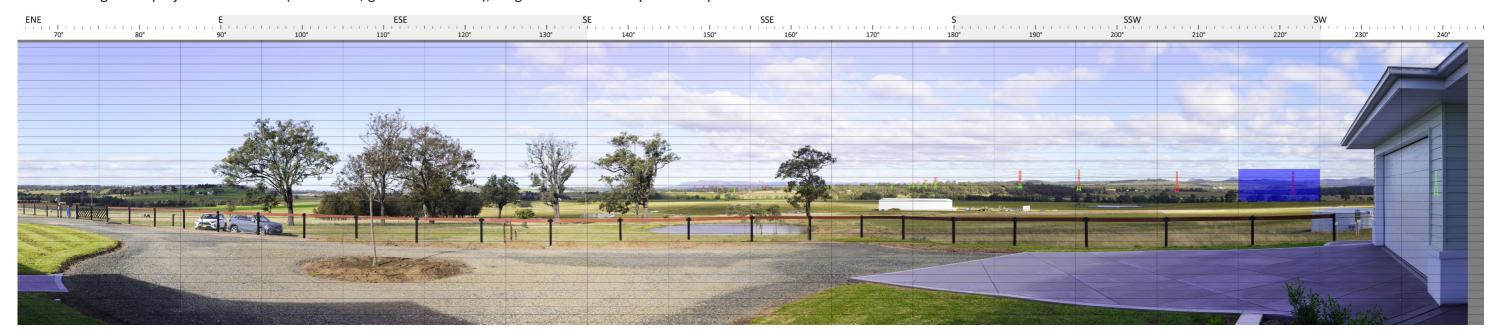
### HTP ID132: 318 Dights Crossing Road, Maison Dieu

Photomontage - including indicative transmission structure locations

Photomontage with project in silhouette (red in view, green out of view), magnitude tool overlay and occupied cell count

Distance to project	Viewpoint type	Viewpoint sensitivity	Scenic quality		Occupied cells	Magnitude rating	Impact rating
1150 metres	Primary view from rural dwelling	Moderate	Moderate	Moderate	4	Very low	Low

Elevated view across cleared rural land on flat to gently undulating land on a bend in the Hunter River. There are scattered trees across the fields and dense vegetation along the river and on a intervening low ridgeline in the middle ground of the view. The view includes a large farm shed, scattered rural dwellings and fencing. The foreground landscape has an open, rural character. In the middle to background of the view is a mining land, including some visible infrastructure.

There are no unique or prominent landscape features in the vicinity, apart from distant views, beyond the mining areas, to distant hills and mountains. While this road is located near to the Hunter River, the river is not visible given the flat terrain and distance.

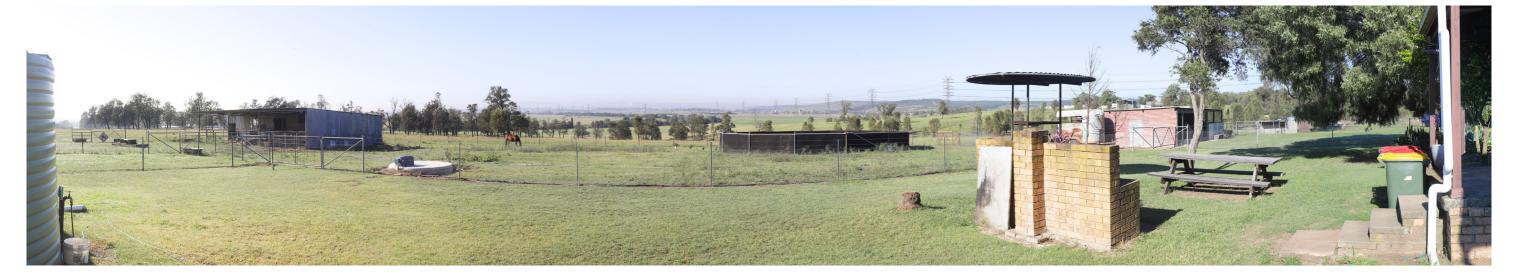
### HTP ID173: 66 Long Point Road East, Gouldsville

Photomontage - including indicative transmission structure locations

Photomontage with project in silhouette (red in view, green out of view), magnitude tool overlay and occupied cell count

Distance to project	Viewpoint type	Viewpoint sensitivity	Scenic quality	Visual sensitivity	Occupied cells	Magnitude rating	Impact rating
725 metres	Primary view from rural dwelling	Moderate	Moderate	Moderate	11	Low	Low

View across cleared rural land on gently undulating land. There is scattered vegetation across the fields and blocks of trees to the east and an area of bushland to the west of the view. The view includes several farm sheds and fencing. The foreground landscape has an rural character.

In the middle ground is a view to mining land, including numerous buildings and existing transmission lines. Beyond the mining areas, are distant views to the undulating landscape and hills

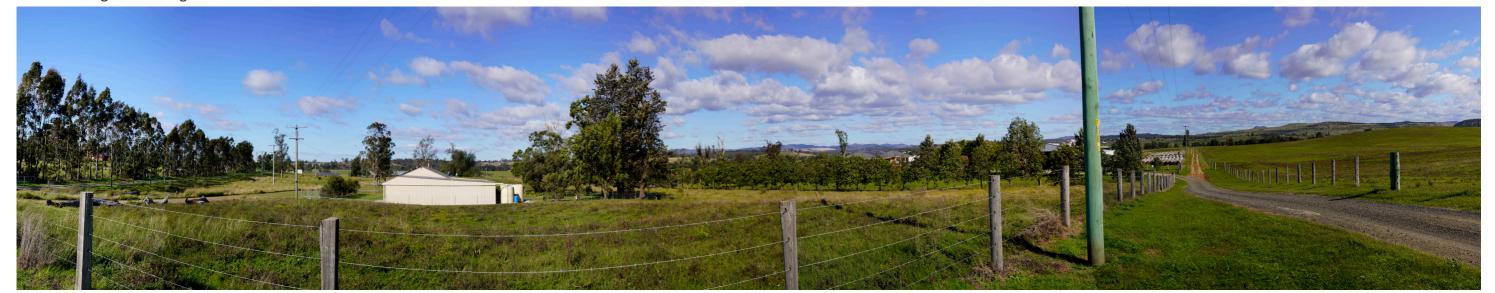
### HTP ID232: 609A Hambledon Hill Road, Hambledon Hill

Photomontage - including indicative transmission structure locations

Photomontage with project in silhouette (red in view, green out of view), magnitude tool overlay and occupied cell count

Flat to gently undulating landform in the foreground, and distant hills. The surrounding fields are largely cleared and has an open, rural character. There is scattered vegetation in the areas surrounding the dwelling as well as a group of

Distance to project	Viewpoint type	Viewpoint sensitivity	Scenic quality	Visual sensitivity	Occupied cells	Magnitude rating	Impact rating
845 metres	Primary view from rural dwelling	Moderate	Low	Moderate	9*	Low	Low

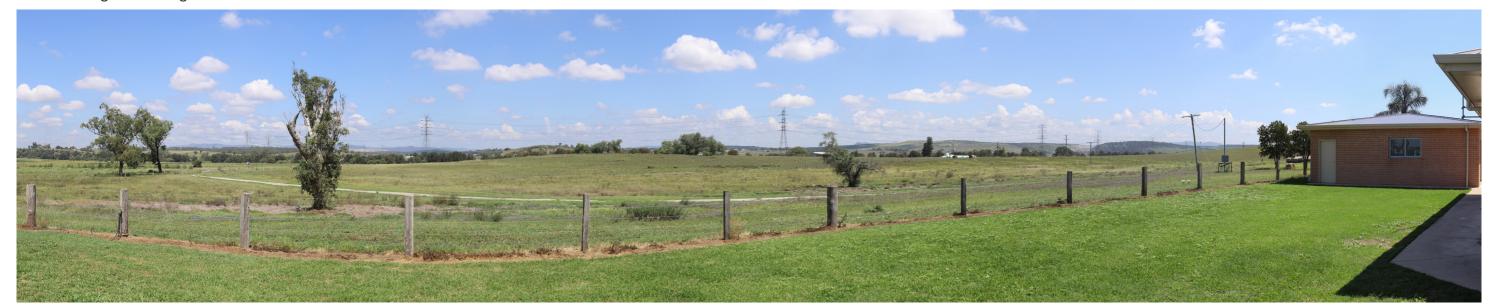
### HTP ID238: 609c Hambledon Hill Road, Hambledon Hill

Photomontage - including indicative transmission structure locations

Photomontage with project in silhouette (red in view, green out of view), magnitude tool overlay and occupied cell count

Distance to project	Viewpoint type	Viewpoint sensitivity	Scenic quality	Visual sensitivity	Occupied cells	Magnitude rating	Impact rating
706 metres	Primary view from rural dwelling	Moderate	Low	Moderate	30	High	Moderate

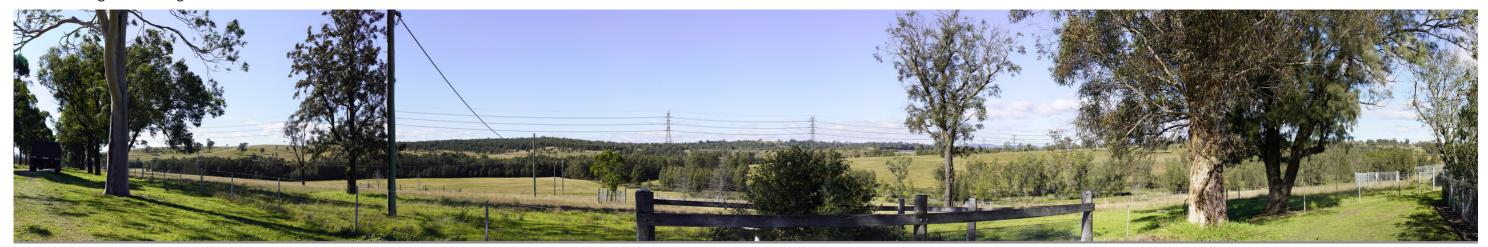
### HTP ID301: 887 Putty Road, Mt Thorley

Photomontage - including indicative transmission structure locations

Photomontage with project in silhouette (red in view, green out of view), magnitude tool overlay and occupied cell count

Distance to project	Viewpoint type	Viewpoint sensitivity	Scenic quality	Visual sensitivity	Occupied cells	Magnitude rating	Impact rating
825 metres	Primary view from rural dwelling	Moderate	Low	Moderate	11	Low	Low

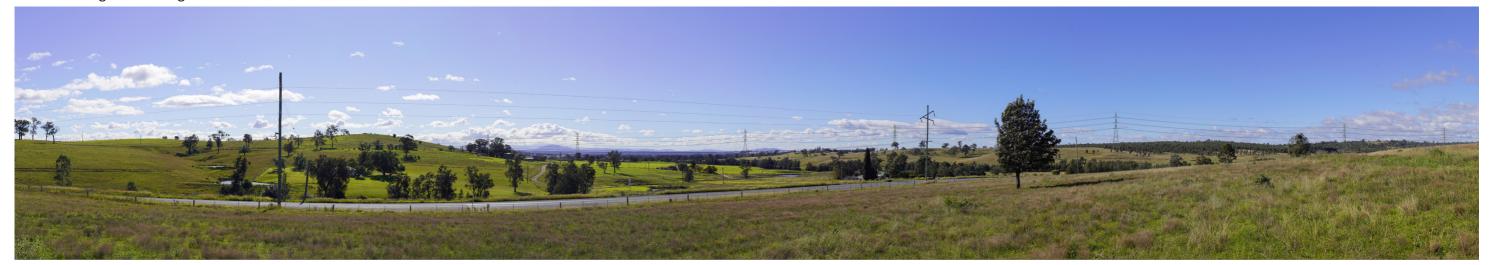
### HTP ID2920: 887 Putty Road, Mount Thorley

Photomontage - including indicative transmission structure locations

Photomontage with project in silhouette (red in view, green out of view), magnitude tool overlay and occupied cell count

Distance to project	Viewpoint type	Viewpoint sensitivity	Scenic quality	Visual sensitivity	Occupied cells	Magnitude rating	Impact rating
XXX metres	Visitor accommodation	Moderate	Low	Moderate	17	Moderate	Moderate

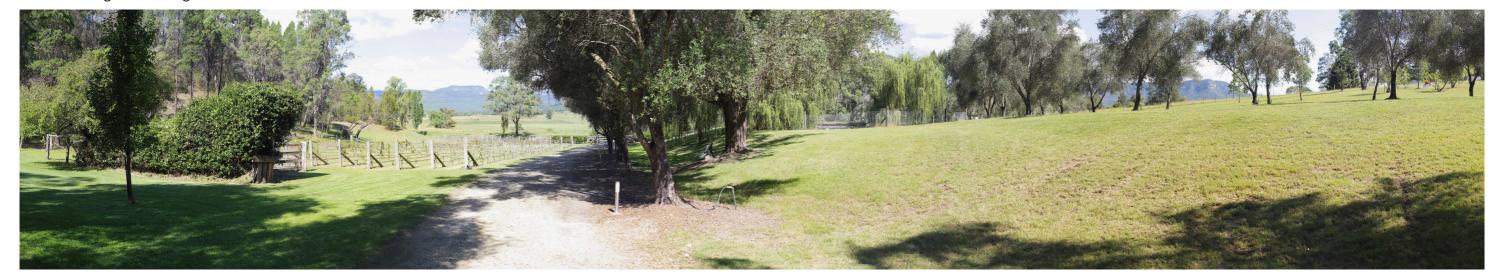
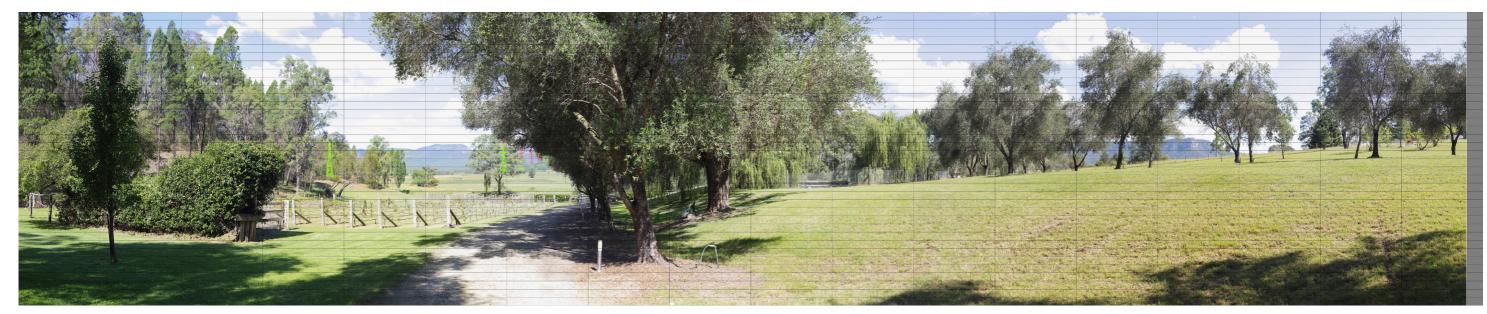
## HTP ID463: 385 Cessnock Road, Broke

Photomontage - including indicative transmission structure locations shown

Photomontage with project in silhouette (red in view, green out of view), magnitude tool overlay and occupied cell count

Distance to project	Viewpoint type	Viewpoint sensitivity	Scenic quality	Visual sensitivity	Occupied cells	Magnitude rating	Impact rating
1058 metres	Primary view from rural dwelling	Moderate	Moderate	Moderate	0	None	None

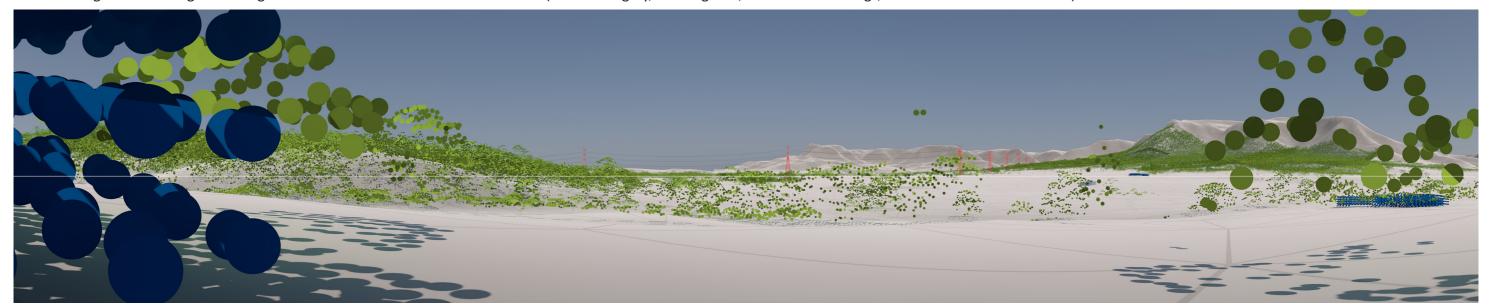
## HTP ID465: 367 Cessnock Road, Broke

Point cloud generated image including indicative transmission structure locations (landform - grey, trees - green, dark blue - buildings, transmission structures - red)

Point cloud generated image including indicative transmission structure locations (red in view, green out of view), magnitude tool overlay and occupied cell count

Distance to project	Viewpoint type	Viewpoint sensitivity	Scenic quality	Visual sensitivity	Occupied cells	Magnitude rating	Impact rating
1132 metres	Primary view from rural dwelling	Moderate	High	High	8	Low	Moderate

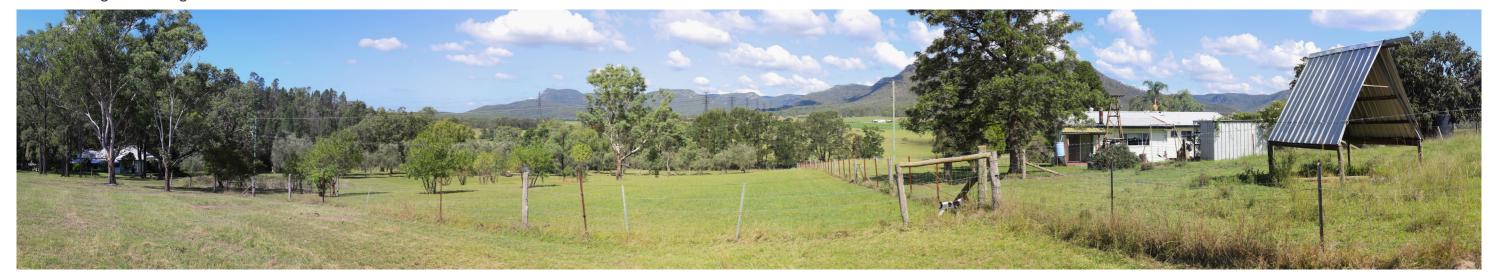
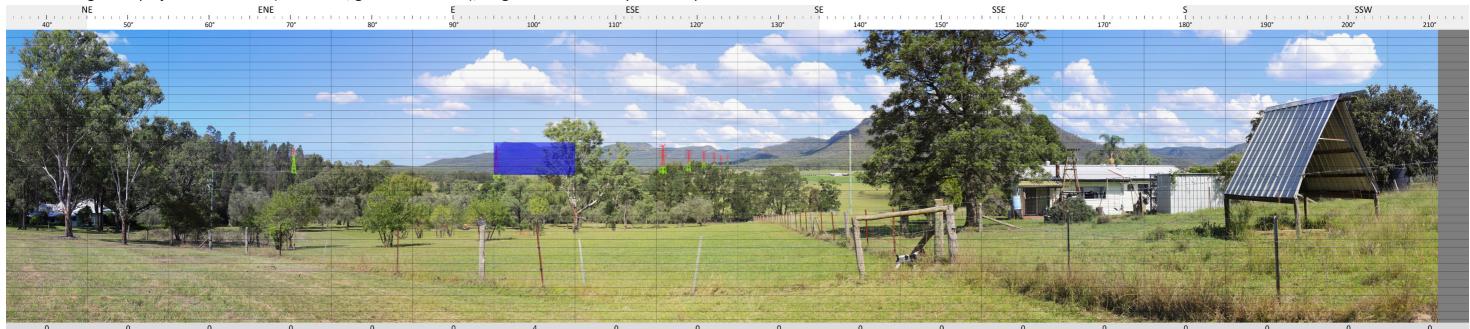
### HTP ID465b: 367 Cessnock Road, Broke

Note, this is a representative viewpoint from the field of the neighbouring property

Photomontage - including indicative transmission structure locations shown in silhouette

Photomontage with project in silhouette (red in view, green out of view), magnitude tool overlay and occupied cell count

Distance to project	Viewpoint type	Viewpoint sensitivity	Scenic quality	Visual sensitivity	Occupied cells	Magnitude rating	Impact rating
1132 metres	Primary view from rural dwelling	Moderate	High	High	4	Very low	Low

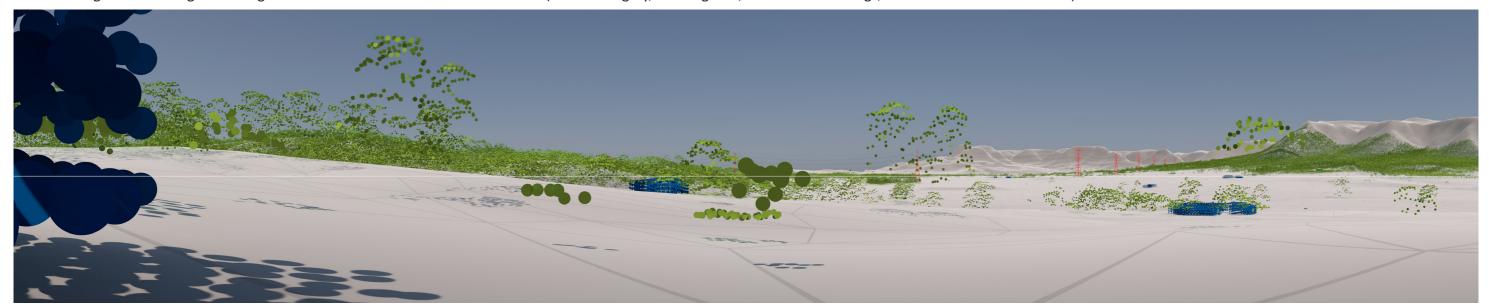
## HTP ID466: 359 Cessnock Road, Broke

Point cloud generated image including indicative transmission structure locations (landform - grey, trees - green, dark blue - buildings, transmission structures - red)

Point cloud generated image including indicative transmission structure locations (red in view, green out of view), magnitude tool overlay and occupied cell count

Distanc	ce to project	Viewpoint type	Viewpoint sensitivity	Scenic quality	Visual sensitivity	Occupied cells	Magnitude rating	Impact rating
1251 m		Primary view from rural dwelling	Moderate	High	High	9	Low	Moderate

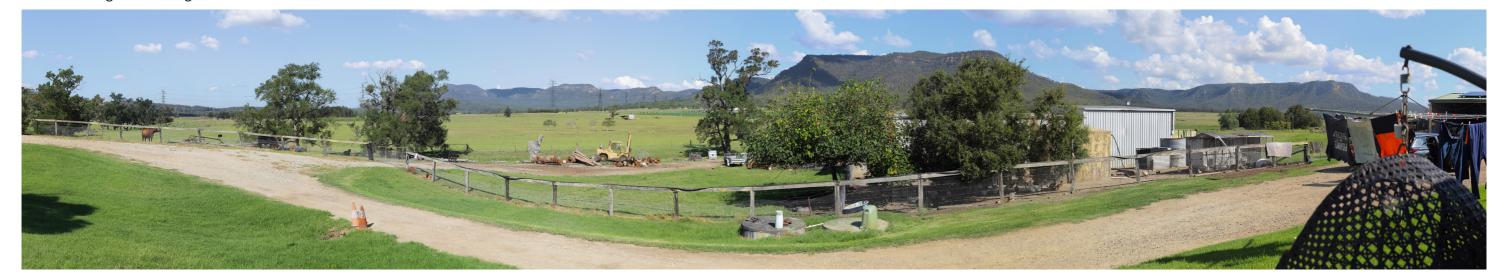
### HTP ID467: 368 Cessnock Road, Broke

Photomontage - including indicative transmission structure locations shown

Photomontage with project in silhouette (red in view, green out of view), magnitude tool overlay and occupied cell count

Distance to project	Viewpoint type	Viewpoint sensitivity	Scenic quality	Visual sensitivity	Occupied cells	Magnitude rating	Impact rating
1080 metres	Primary view from rural dwelling	Moderate	High	High	8	Low	Moderate

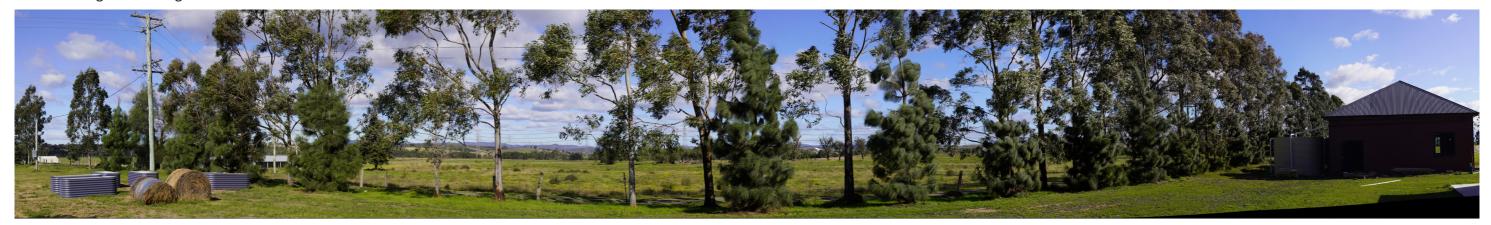
### HTP ID2925: 535c Hambledon Hill Road, Hambledon Hill

Photomontage - including indicative transmission structure locations

Photomontage with project in silhouette (red in view, green out of view), magnitude tool overlay and occupied cell count

Distance to project	Viewpoint type	Viewpoint sensitivity	Scenic quality	Visual sensitivity	Occupied cells	Magnitude rating	Impact rating
900 metres	View from rural dwelling	Moderate	Moderate	Moderate	12	Low	Low

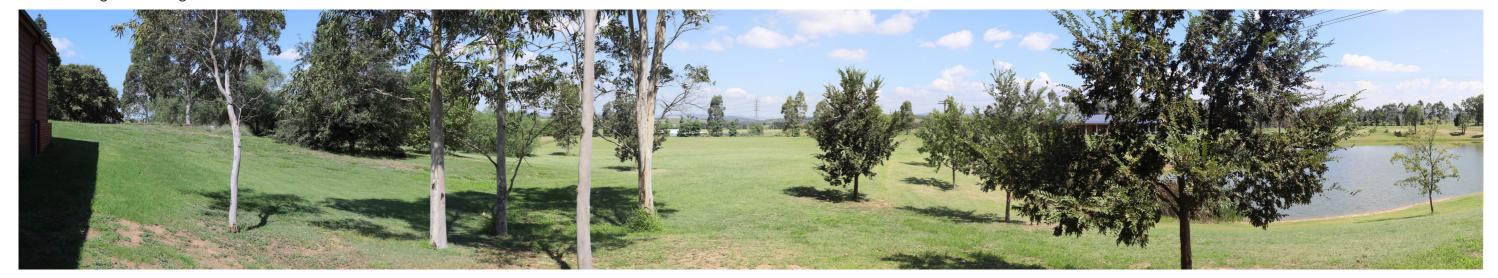
## HTP ID2926b: 'Hambledon Hill', 535c Hambledon Hill Road, Hambledon Hill

Photomontage - including indicative transmission structure locations

Photomontage with project in silhouette (red in view, green out of view), magnitude tool overlay and occupied cell count

Distance to project	Viewpoint type	Viewpoint sensitivity	Scenic quality	Visual sensitivity	Occupied cells	Magnitude rating	Impact rating
1,200 metres	Secondary view from historic homestead	High	Moderate	High	4	Very low	Low

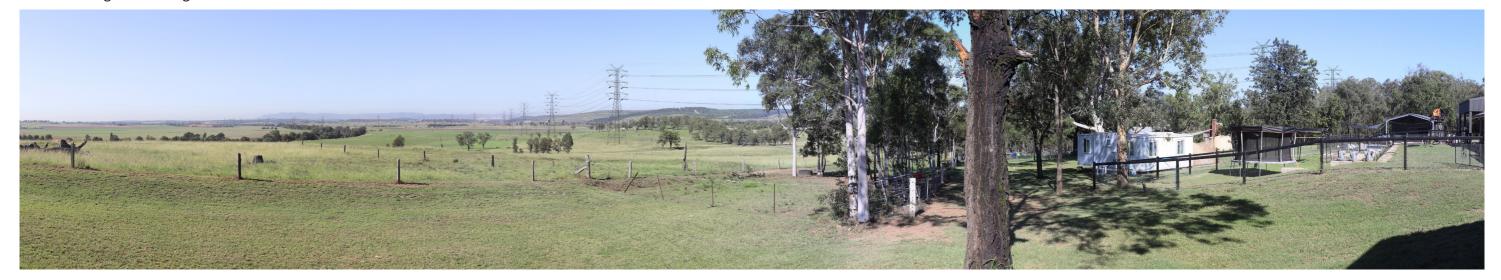
### HTP ID2928: 16 Long Point Road East, Gouldsville

Photomontage - including indicative transmission structure locations

Photomontage with project in silhouette (red in view, green out of view), magnitude tool overlay and occupied cell count

Distance to project	Viewpoint type	Viewpoint sensitivity	Scenic quality	Visual sensitivity	Occupied cells	Magnitude rating	Impact rating
334 metres	Primary view from rural dwelling	Moderate	Low	Moderate	22	Moderate	Moderate

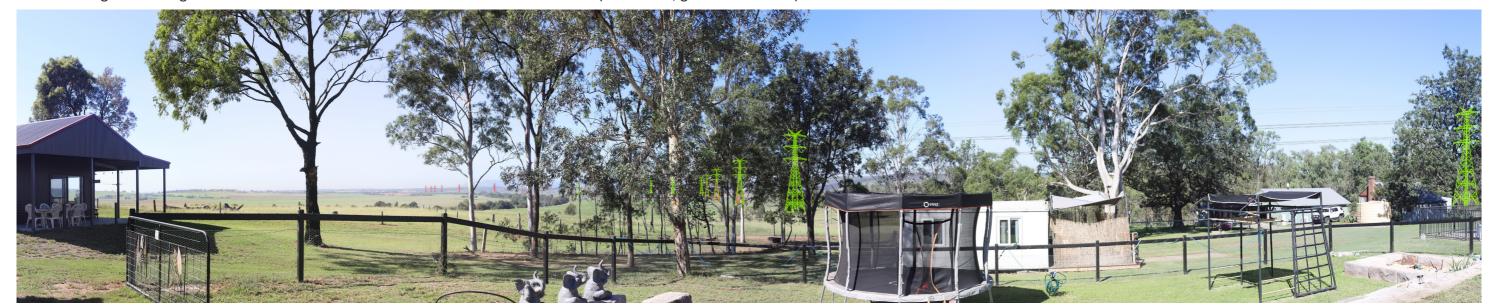
### HTP ID2929: 16 Long Point Road East, Gouldsville

Photomontage - including indicative transmission structure locations shown in silhouette (red in view, green out of view)

Photomontage with project in silhouette (red in view, green out of view), magnitude tool overlay and occupied cell count

Distance to project	Viewpoint type	Viewpoint sensitivity	Scenic quality	Visual sensitivity	Occupied cells	Magnitude rating	Impact rating
334 metres	Primary view from rural dwelling	Moderate	Low	Moderate	0	None	None

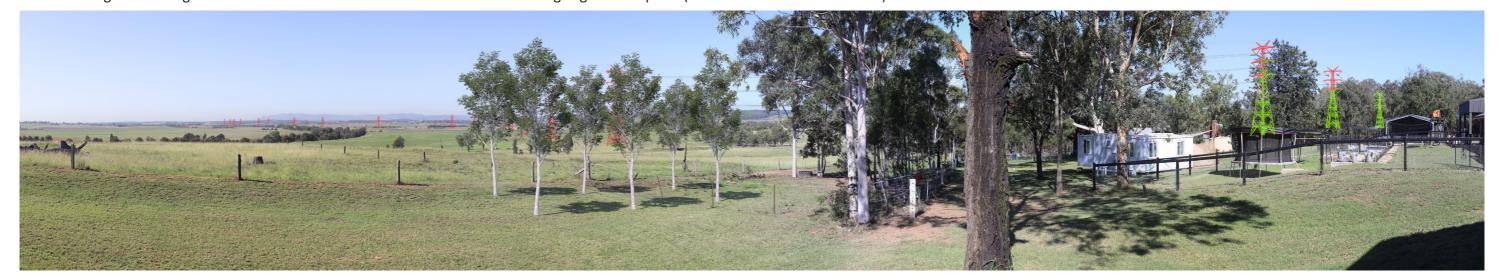
### HTP ID2928: 16 Long Point Road East, Gouldsville

Photomontage - including indicative transmission structure locations and screening vegetation option (trees shown at 4-5 metres tall)

Photomontage with project in silhouette (red in view, green out of view), magnitude tool overlay and occupied cell count

Distance to project	Viewpoint type	Viewpoint sensitivity		Visual sensitivity	Mitigation opportunity	Occupied cells	Magnitude rating	Residual visual impact rating
334 metres	Primary view from rural dwelling	Moderate	Low	Moderate	A double offset row of trees along fenceline adjacent to existing block of trees. Trees shown at 4-5 metres tall to indicate the screening effect of this vegetation in the short term.	0	Nil	No impact

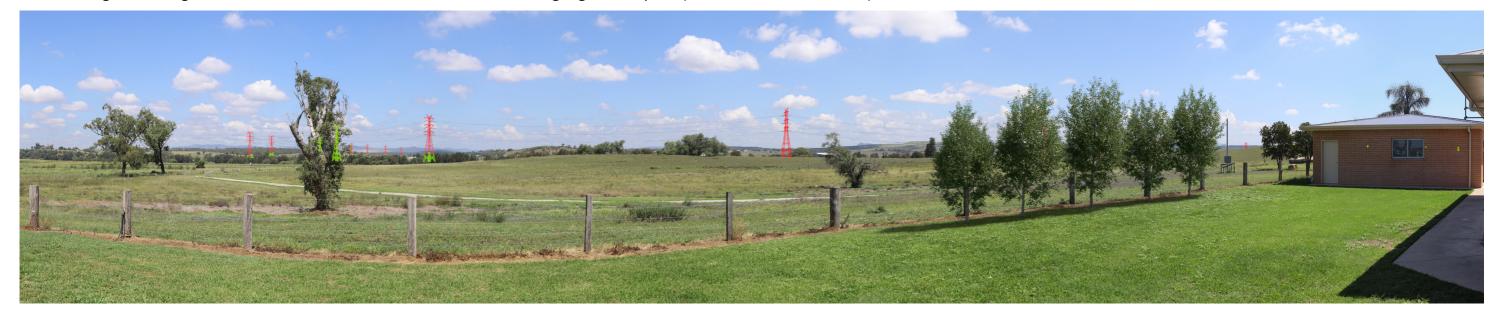
### HTP ID238: 609c Hambledon Hill Road, Hambledon Hill

Photomontage - including indicative transmission structure locations and screening vegetation option (trees shown at 2 metres tall)

Photomontage with project in silhouette (red in view, green out of view), magnitude tool overlay and occupied cell count

Distance to project	Viewpoint type	Viewpoint sensitivity		Visual sensitivity	Mitigation opportunity	Occupied cells	Magnitude rating	Residual visual impact rating
334 metres	Primary view from rural dwelling	Moderate	Low	Moderate	A single row of large shrubs / trees along fenceline to the west of the view. Trees shown at 2 metres tall to indicate the screening effect of this vegetation in the short term. This vegetation would not obstruct the distant hills that are located to the south of the view.	15	Low	Low

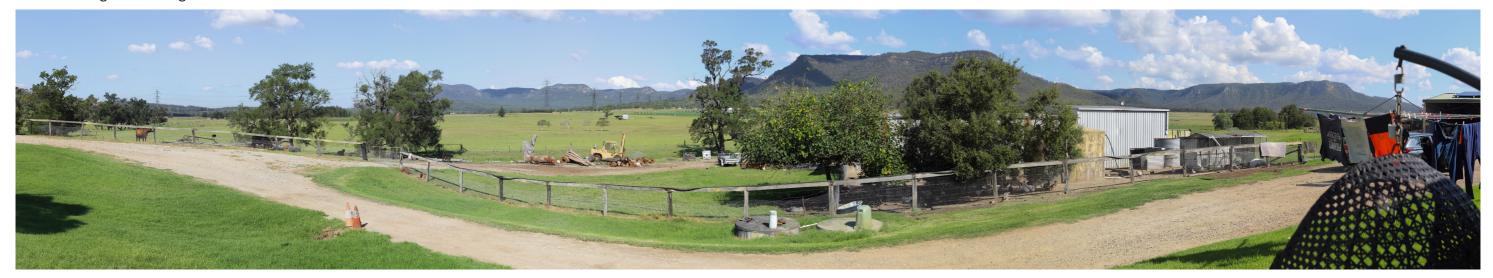
## HTP ID467: 368 Cessnock Road, Broke

Photomontage - including indicative transmission structure locations shown

Photomontage with project in silhouette (red in view, green out of view), magnitude tool overlay and occupied cell count

Distance to project	Viewpoint type	Viewpoint sensitivity	Scenic quality	Visual sensitivity	Mitigation opportunity	Occupied cells		Residual visual impact rating
1080 metres	Primary view from rural dwelling	Moderate	High	High	Trees along the track to the northeast of the dwelling to screen transmission line structures closest to the dwelling. Trees in this location would not obstruct the distant hills that are located to the southeast of the view which are the focal point of the view.	4 (excluding cells highlighted in white)	Very low	Low

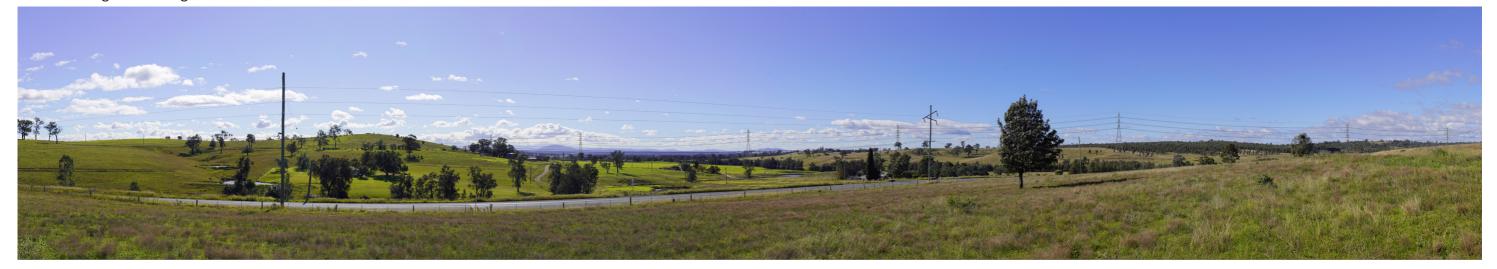
### HTP ID2920: 887 Putty Road, Mount Thorley

Photomontage - including indicative transmission structure locations

Photomontage with project in silhouette (red in view, green out of view), magnitude tool overlay and occupied cell count

Distance to project	Viewpoint type	Viewpoint sensitivity	Scenic quality	Visual sensitivity	Mitigation opportunity	Occupied cells	Magnitude rating	Residual visual impact rating
980 metres	Visitor accommodation	Moderate	Low	Moderate	Screening vegetation to the southeast of the dwelling to screen transmission line structures Trees in this location would not obstruct the distant hills that are located to the north to northeast of the view which are the focal point of the view.	15 (excluding cells highlighted in white)	Low	Low
