# 2024 Cadia Mine Rehabilitation Monitoring Report

for  
Newmont Corporation  
(Australia)

Prepared by  
DnA Environmental  
May 2024

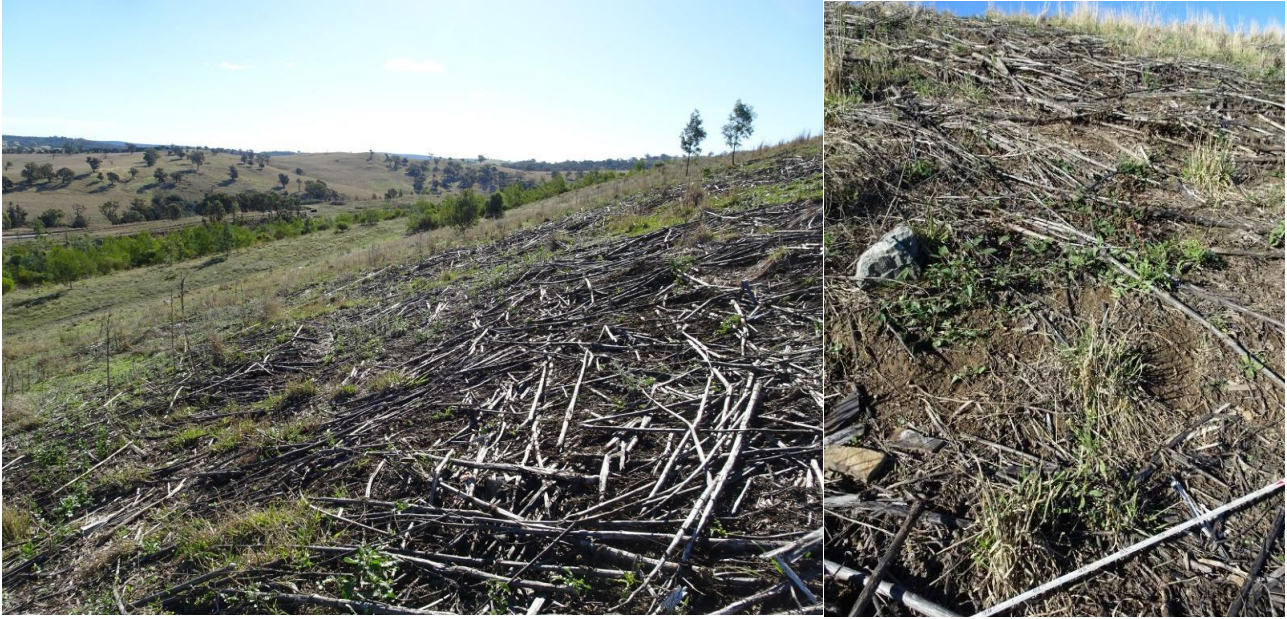
**Figure 9-2. South Dump 10 is dominated by exotic species and requires additional rehabilitation in order to meet completion criteria targets.**

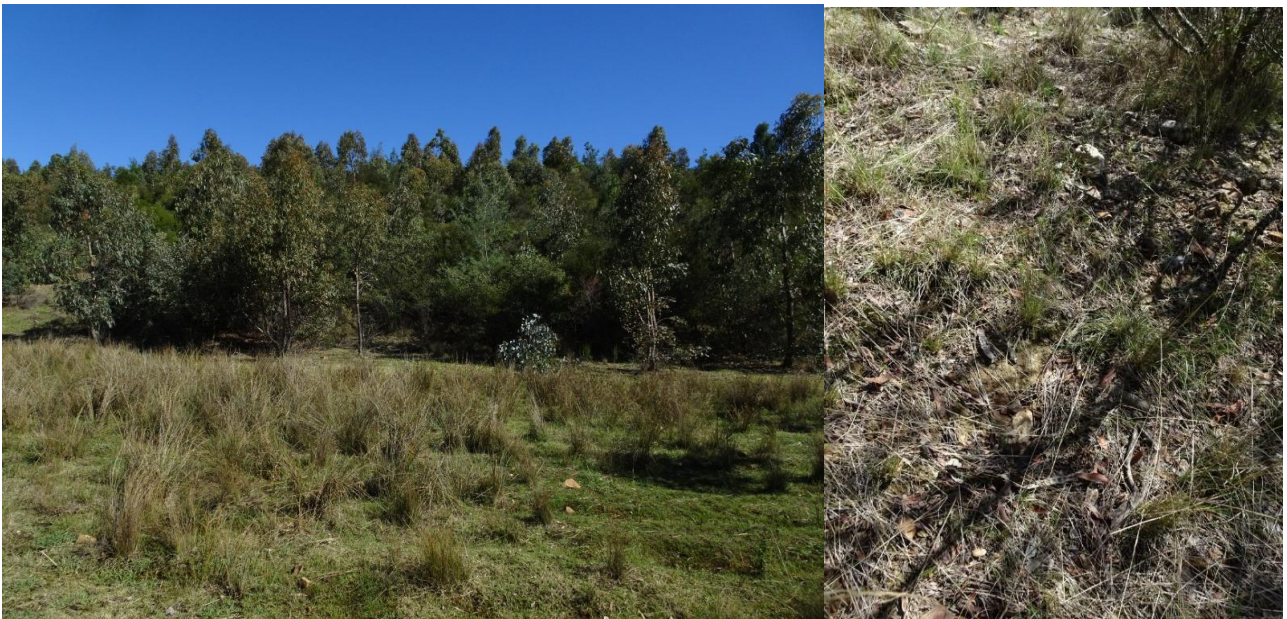
Exotic pasture species and weeds were limited in rehabilitation sites South Dump 07 and South Dump 08, with successful establishment of a high diversity of native woodland species, including native grasses which have become the dominant form of ground cover. Subsequently, all additional rehabilitation programs should utilise weed free topsoil/subsoil and exclude sowing exotic pastures to ensure self-sustaining communities to become established. In addition, *Juncus* species and a range of other moisture loving species have also naturally colonised moist depressions along contour banks and drainage depressions in some parts of the SWRD (Figure 9-3).

**Figure 9-3. South Dump 07 has had successful establishment of a diversity of native species, including native grasses such as *Austrostipa scabra*, *Rytidosperma* spp. and *Juncus* spp. have been increasing in abundance.**

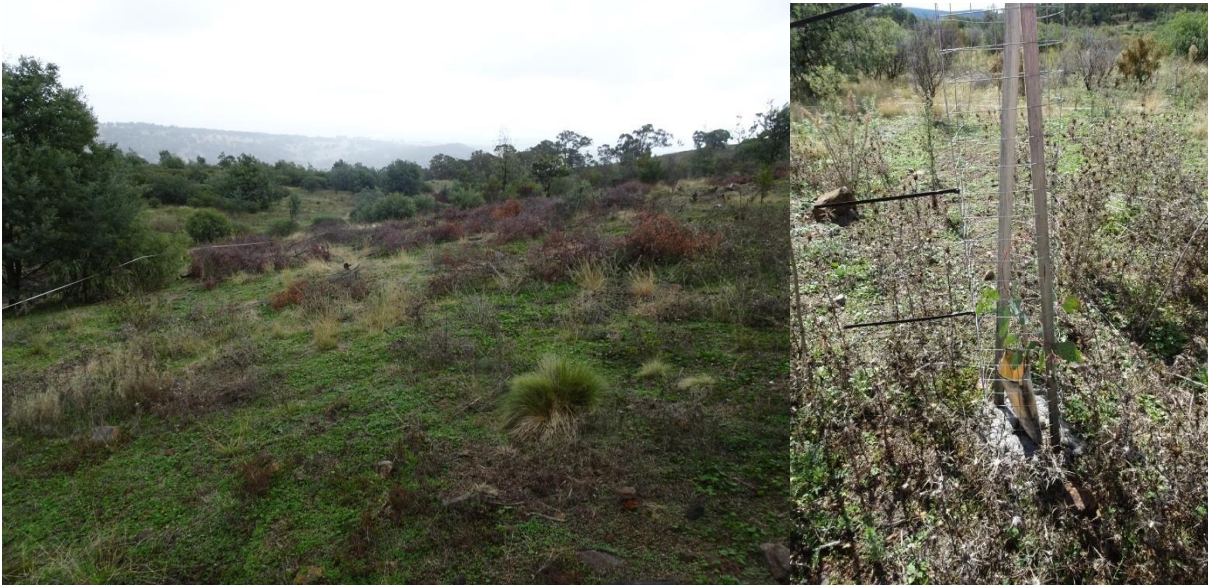
Figure 9-4. Removal of acacia saplings and planting of eucalypt tubestock on the North Dump.
