Detailed Site Investigation Report – Rosalind Street (WP12)

Document No. SPA-JGA-REP-ENV-WP12-1-0005

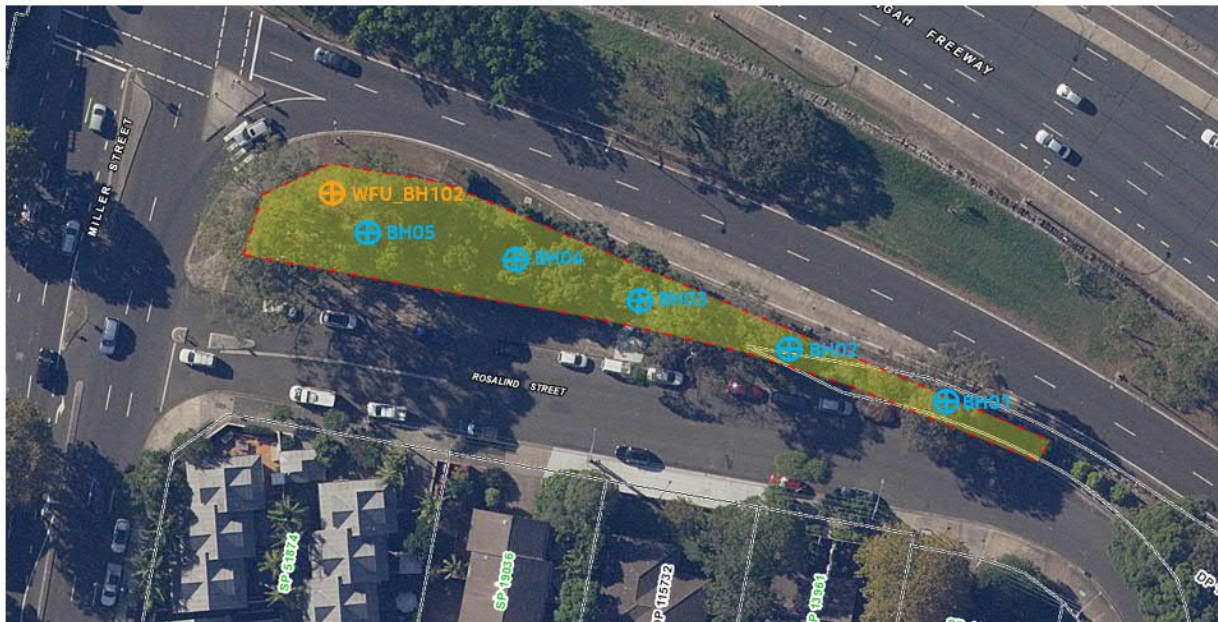
Figure 7-1: Approximate investigation locations

The approximate investigation locations undertaken by SMEC (2020) and SPA are presented on **Figure 7-1**.

⊕ Approximate SMEC investigation location

⊕ Approximate Jacobs investigation location
