6.6 Soils and surface water

This section provides a summary of the assessment of potential soils and surface water impacts during construction and operation of the proposal and identifies mitigation measures to address these impacts. A detailed assessment of soil and surface water quality impacts is provided in the technical working paper – soils and surface water assessment (Appendix I).

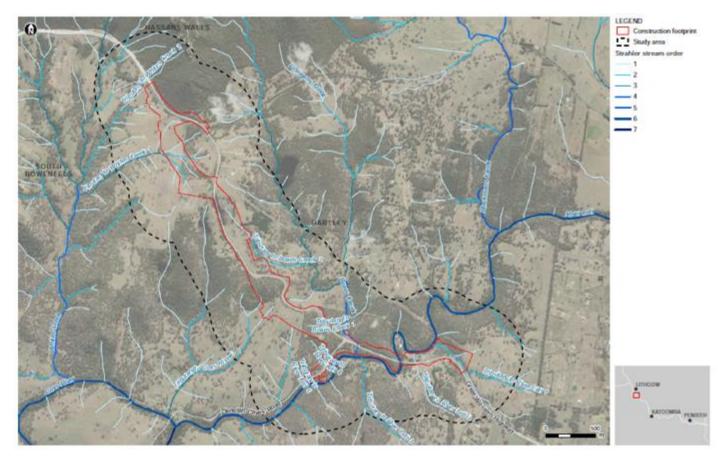
Figure 6-24 Soils and surface water quality study area - River Lett Hill to Forty Bends

There are numerous waterways and waterbodies including major perennial waterways, minor intermittent creeks, ephemeral drainage channels and waterbodies such as farm dams, present within proximity of the construction footprint. Waterways present within each section are listed in Table 6-78 and shown in Figure 6-22 to Figure 6-25.

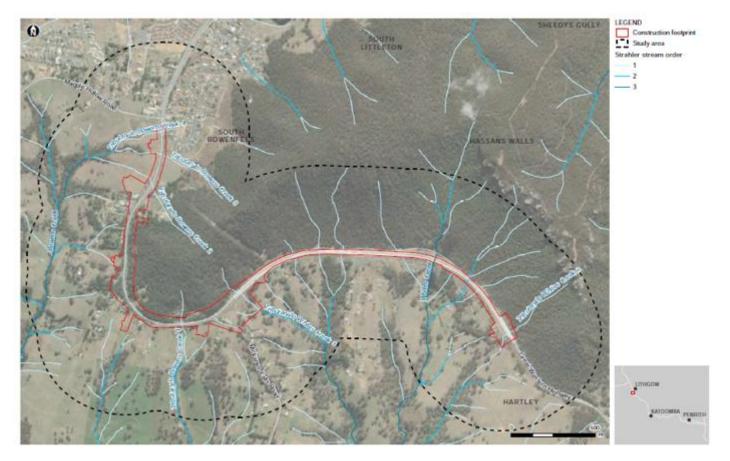
Figure 6-25 Soils and surface water quality study area - Forty Bends to Lithgow
