# WESTERN HARBOUR TUNNEL - BERRYS BAY SITE

## Final Excavation Report

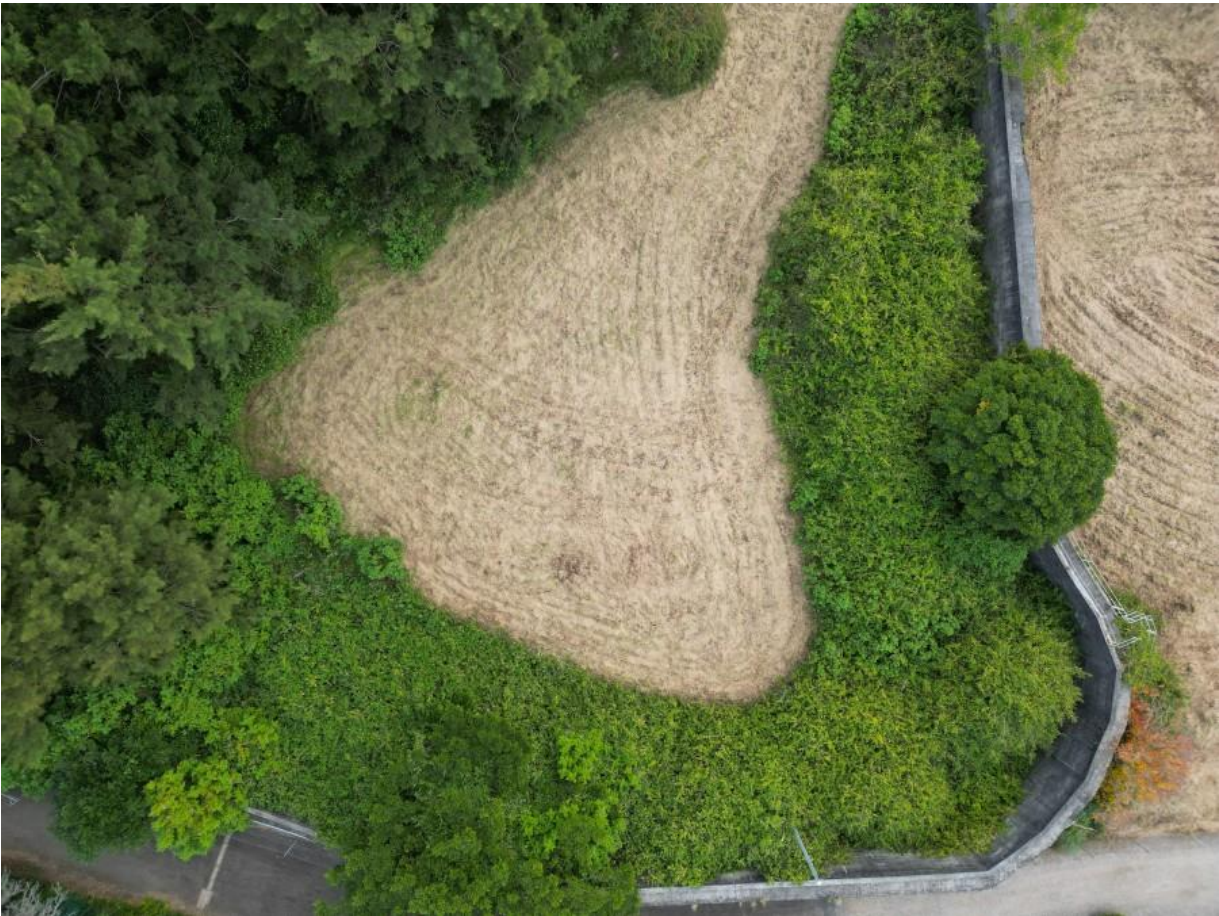
Figure 3-4: The ground conditions in Area A prior to excavation of Trench 1 and Trench 3. [CRM for RPS 2023].

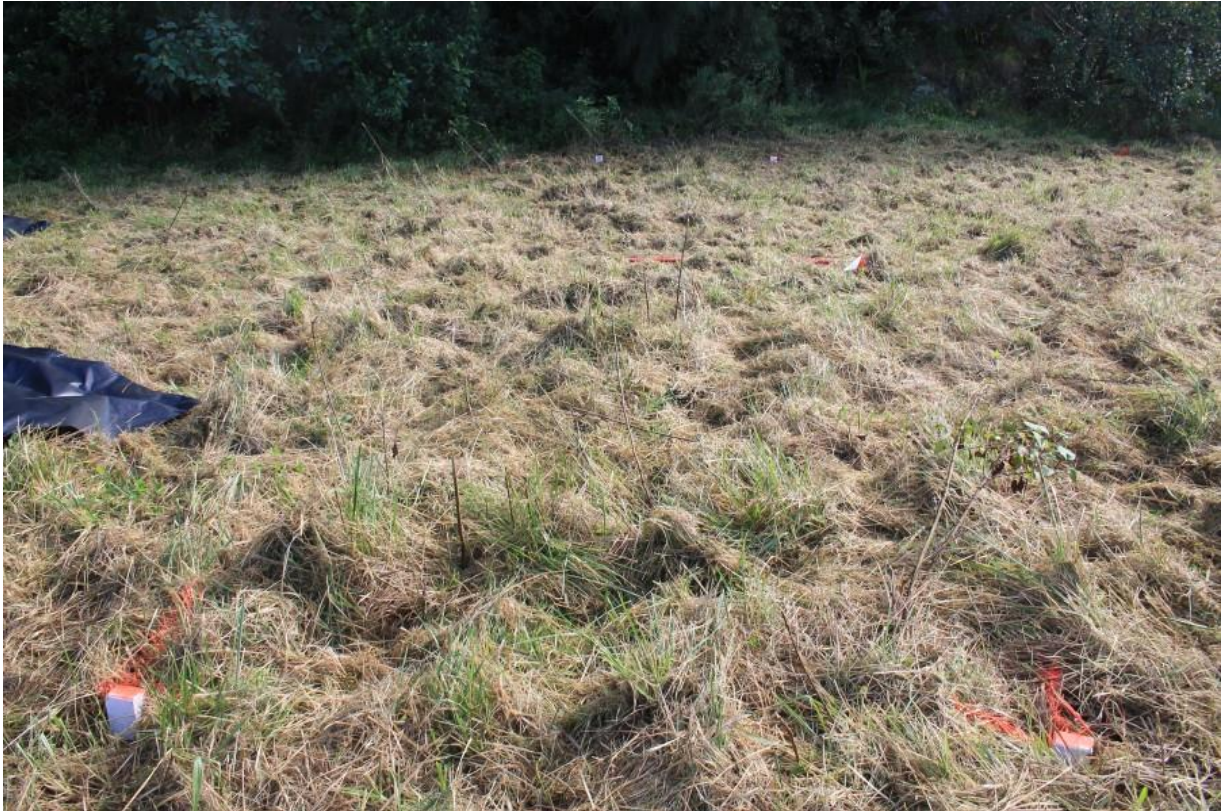
Figure 3-5: Trench 1 prior to excavation showing the grass coverage (1000). View to the north, scale 2 metres. [CRM for RPS].

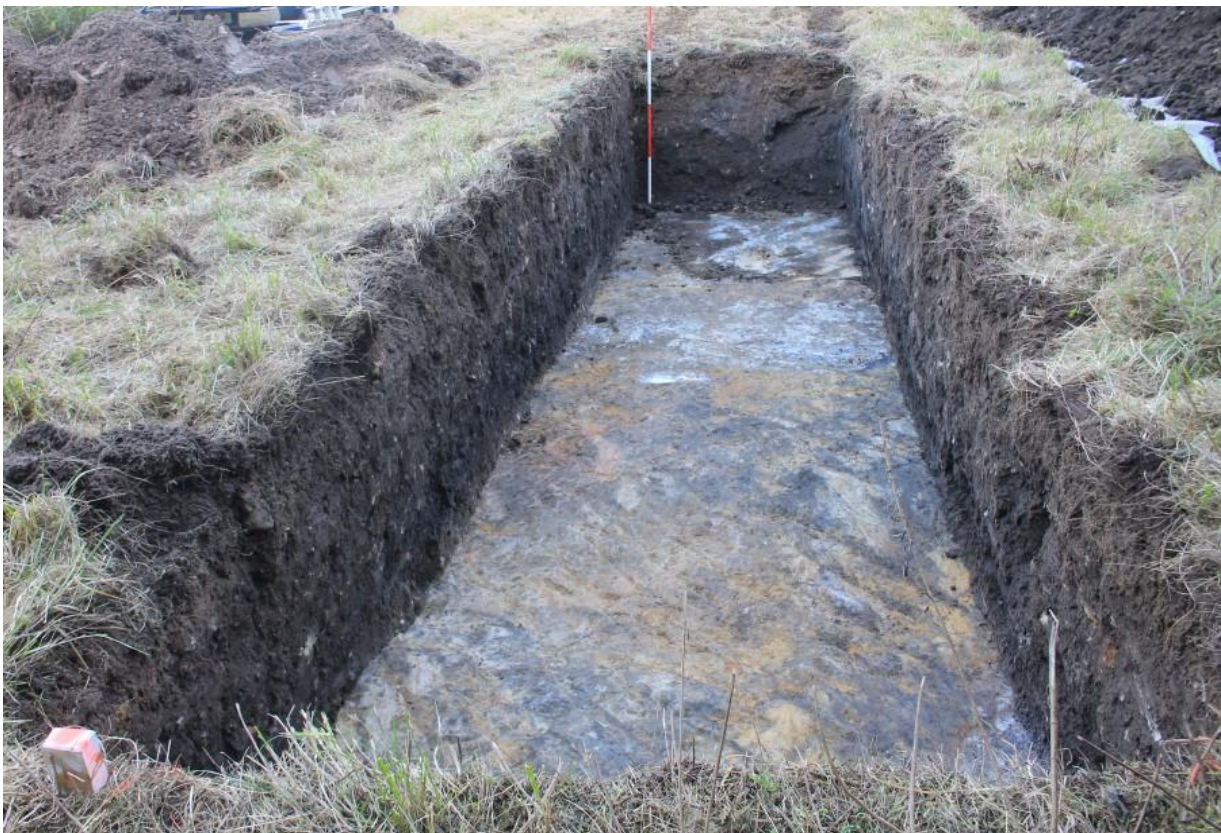
**Figure 3-8: Bedrock (1003) at the base of Trench 1. In the foreground the parallel gouges in the rock caused by an excavator bucket are clearly evident. View to the south, scale 2 metres. [CRM for RPS].**

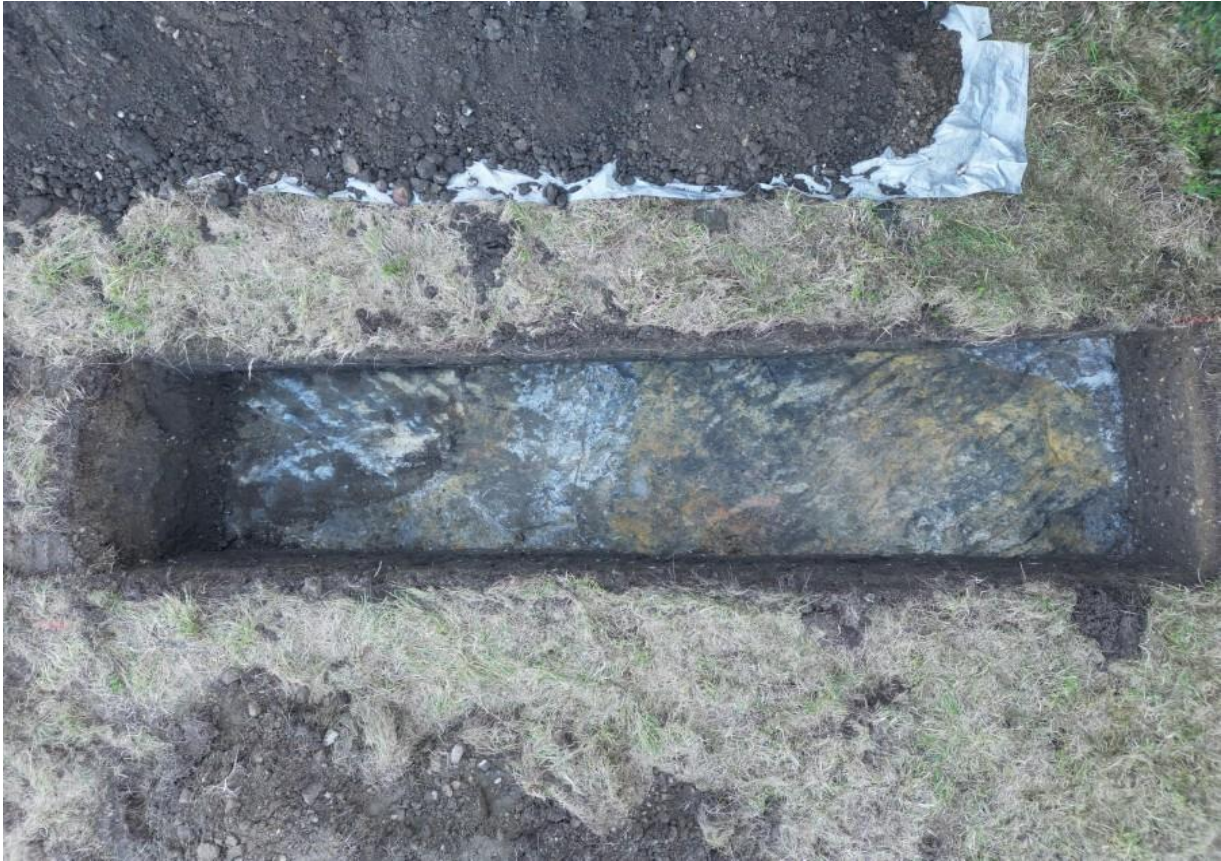
**Figure 3-9: Overhead view of Trench 1 and the cessation of excavations demonstrating the bedrock (1003) base with excavator bucket marks evident. View to the west, no scale. [CRM for RPS].**

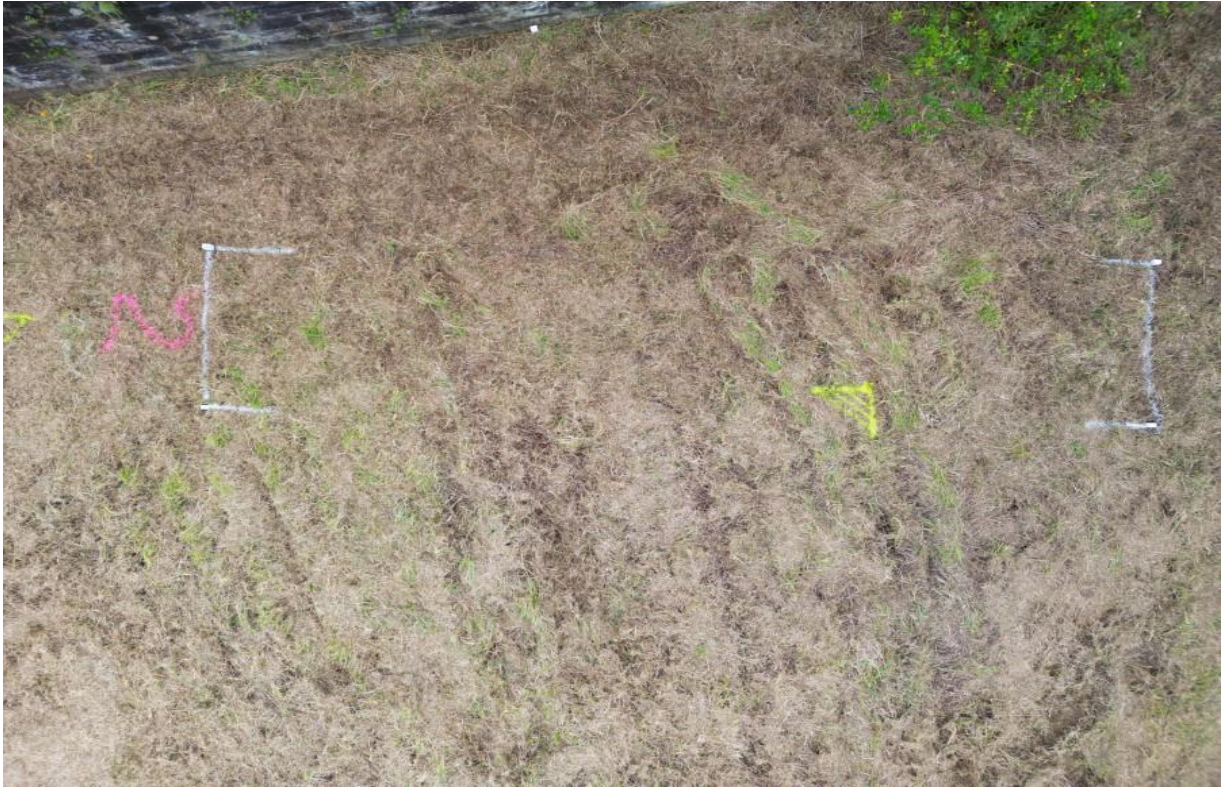
Figure 3-12: Trench 2 prior to excavation showing grass cover (2000). The bund wall is west of the trench at the top of the image above. View to the west, no scale. [CRM for RPS].

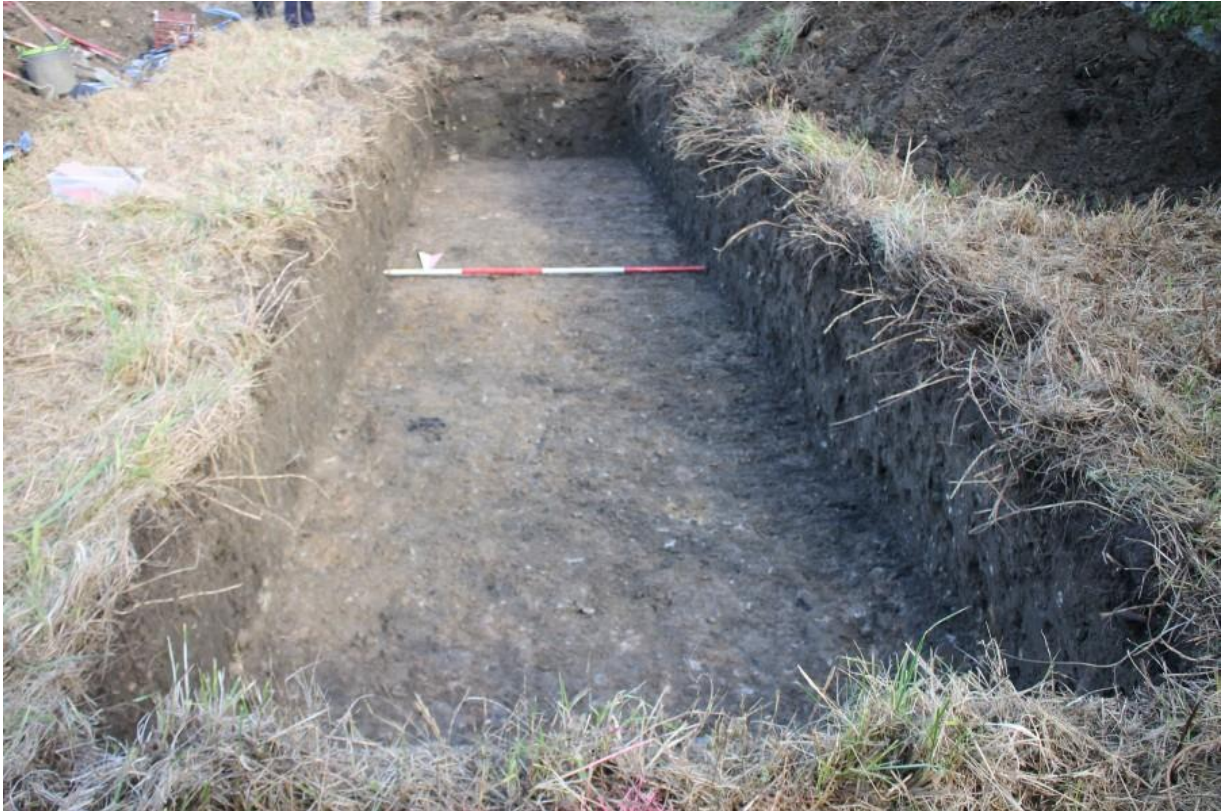
Figure 3-16: The surface of the lower level of fill (2003) found beneath (2002) in Trench 2. View to the south, scale 2 metres. [CRM for RPS].

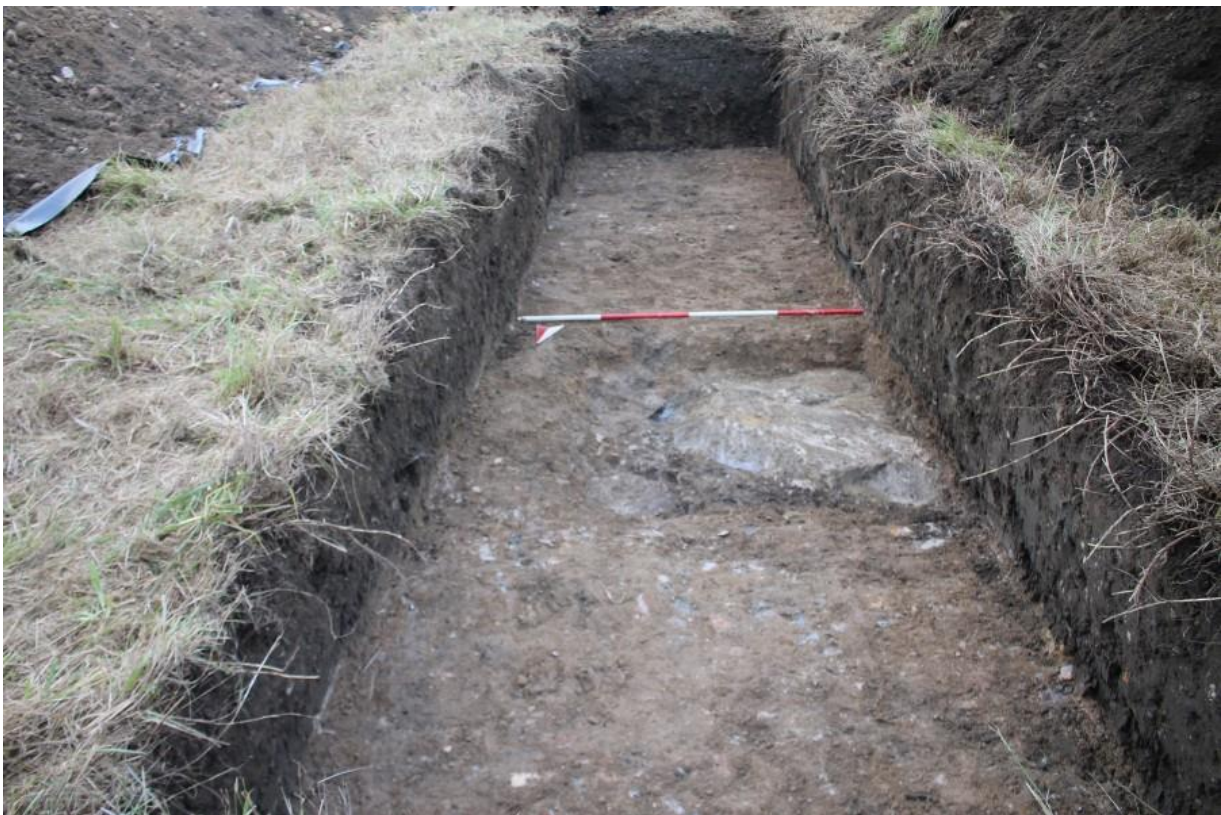
Figure 3-17: The small cut feature [2005] in the western side of Trench 2 that may have occurred during the removal of an earlier structure. View to the south, scale 2 metres. [CRM for RPS].

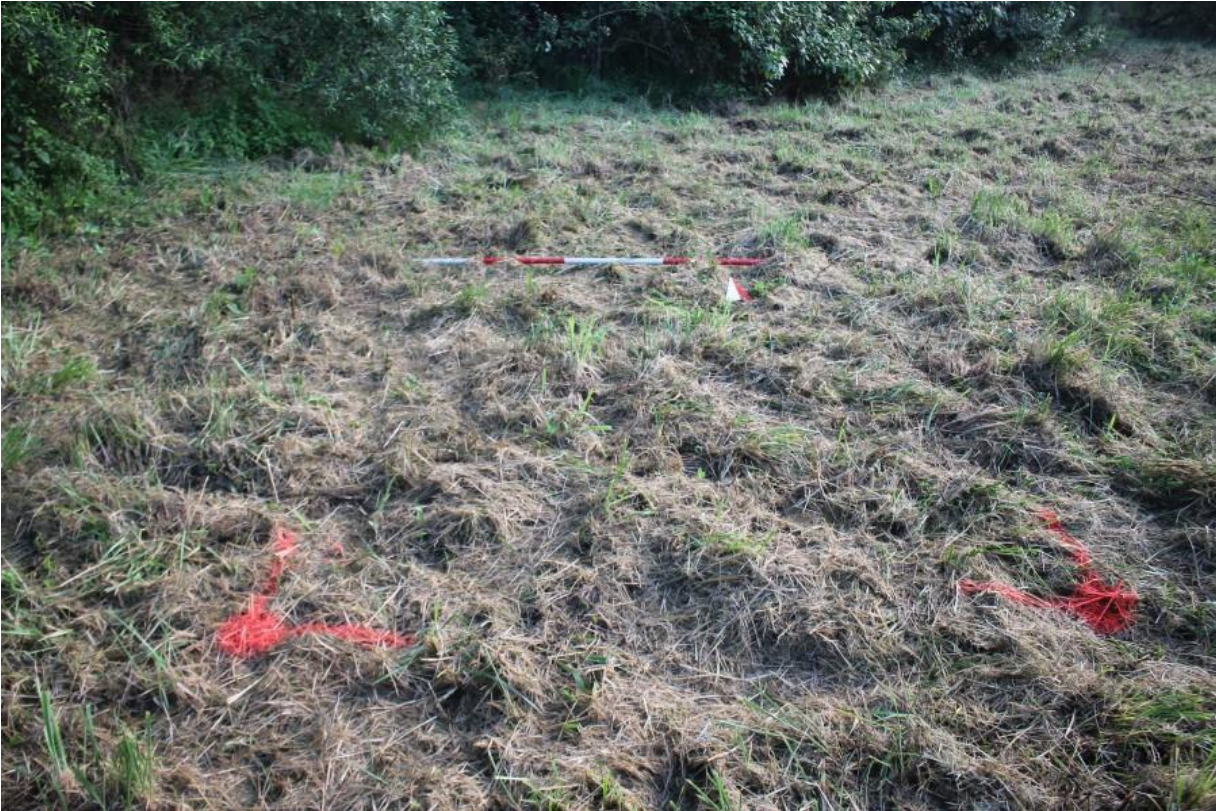
Figure 3-21: Trench 3 prior to excavation showing the grass coverage (3000). View to the north, scale 2 metres. [CRM for RPS].

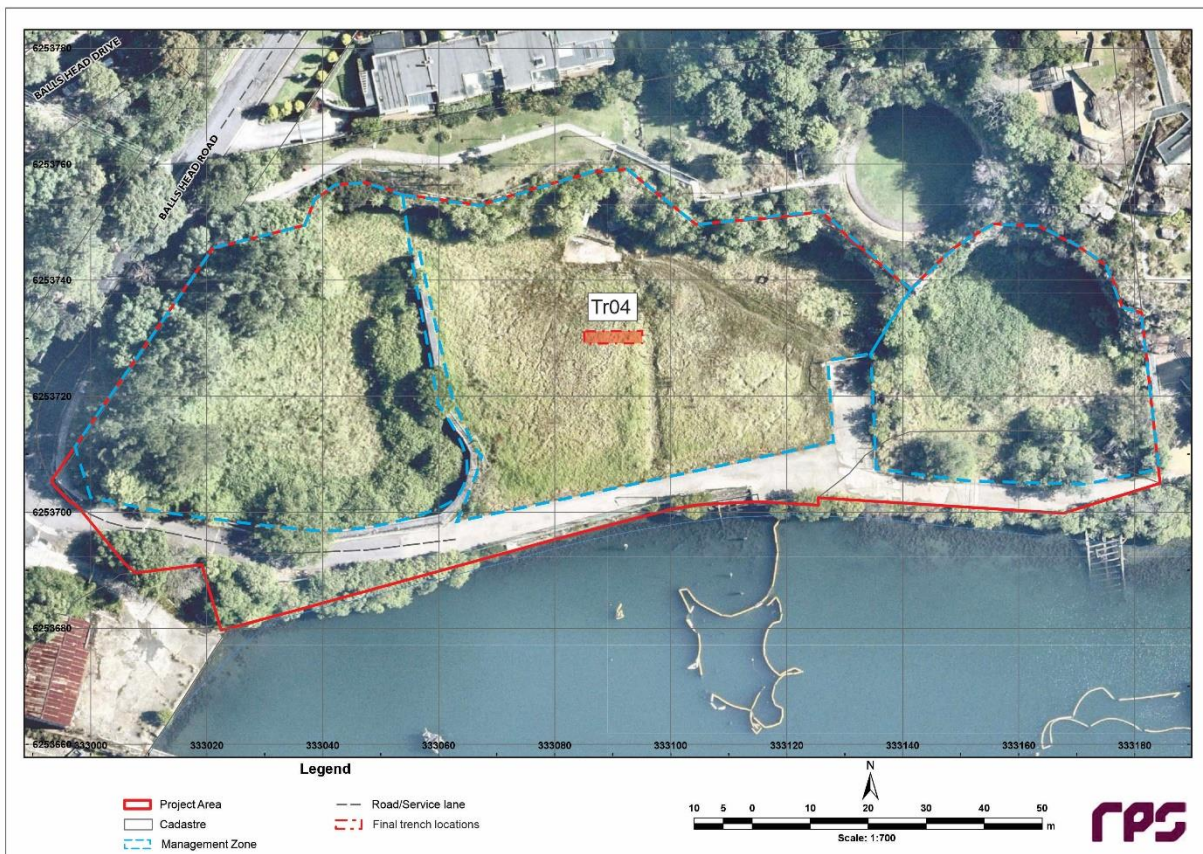
Figure 3-27: The project site showing the location of Trench 4 in Area B.

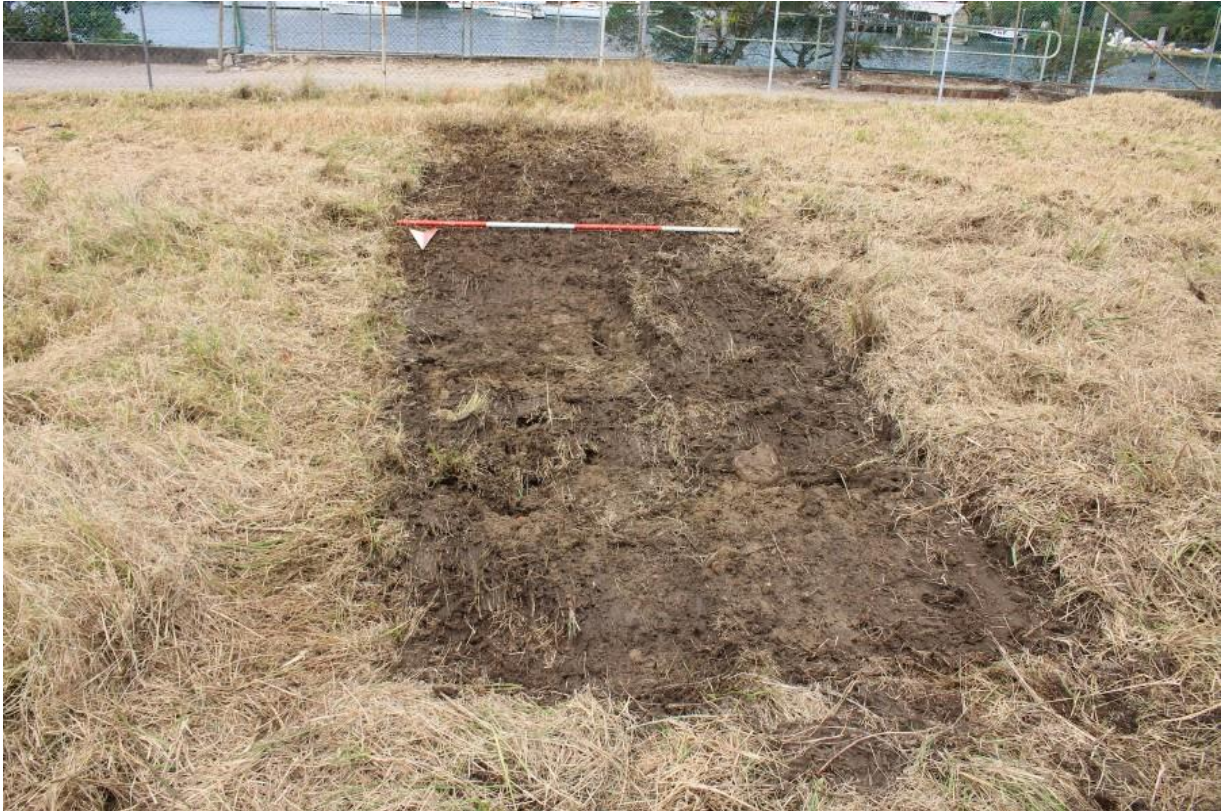
Figure 3-39: Trench 5 following the removal of the grass showing the surface of the topsoil (5001). View to the south, scale 2 metres. [CRM for RPS].
