# **Rehabilitation Strategy**

**Document No. 710-005-EN-STR-0002**

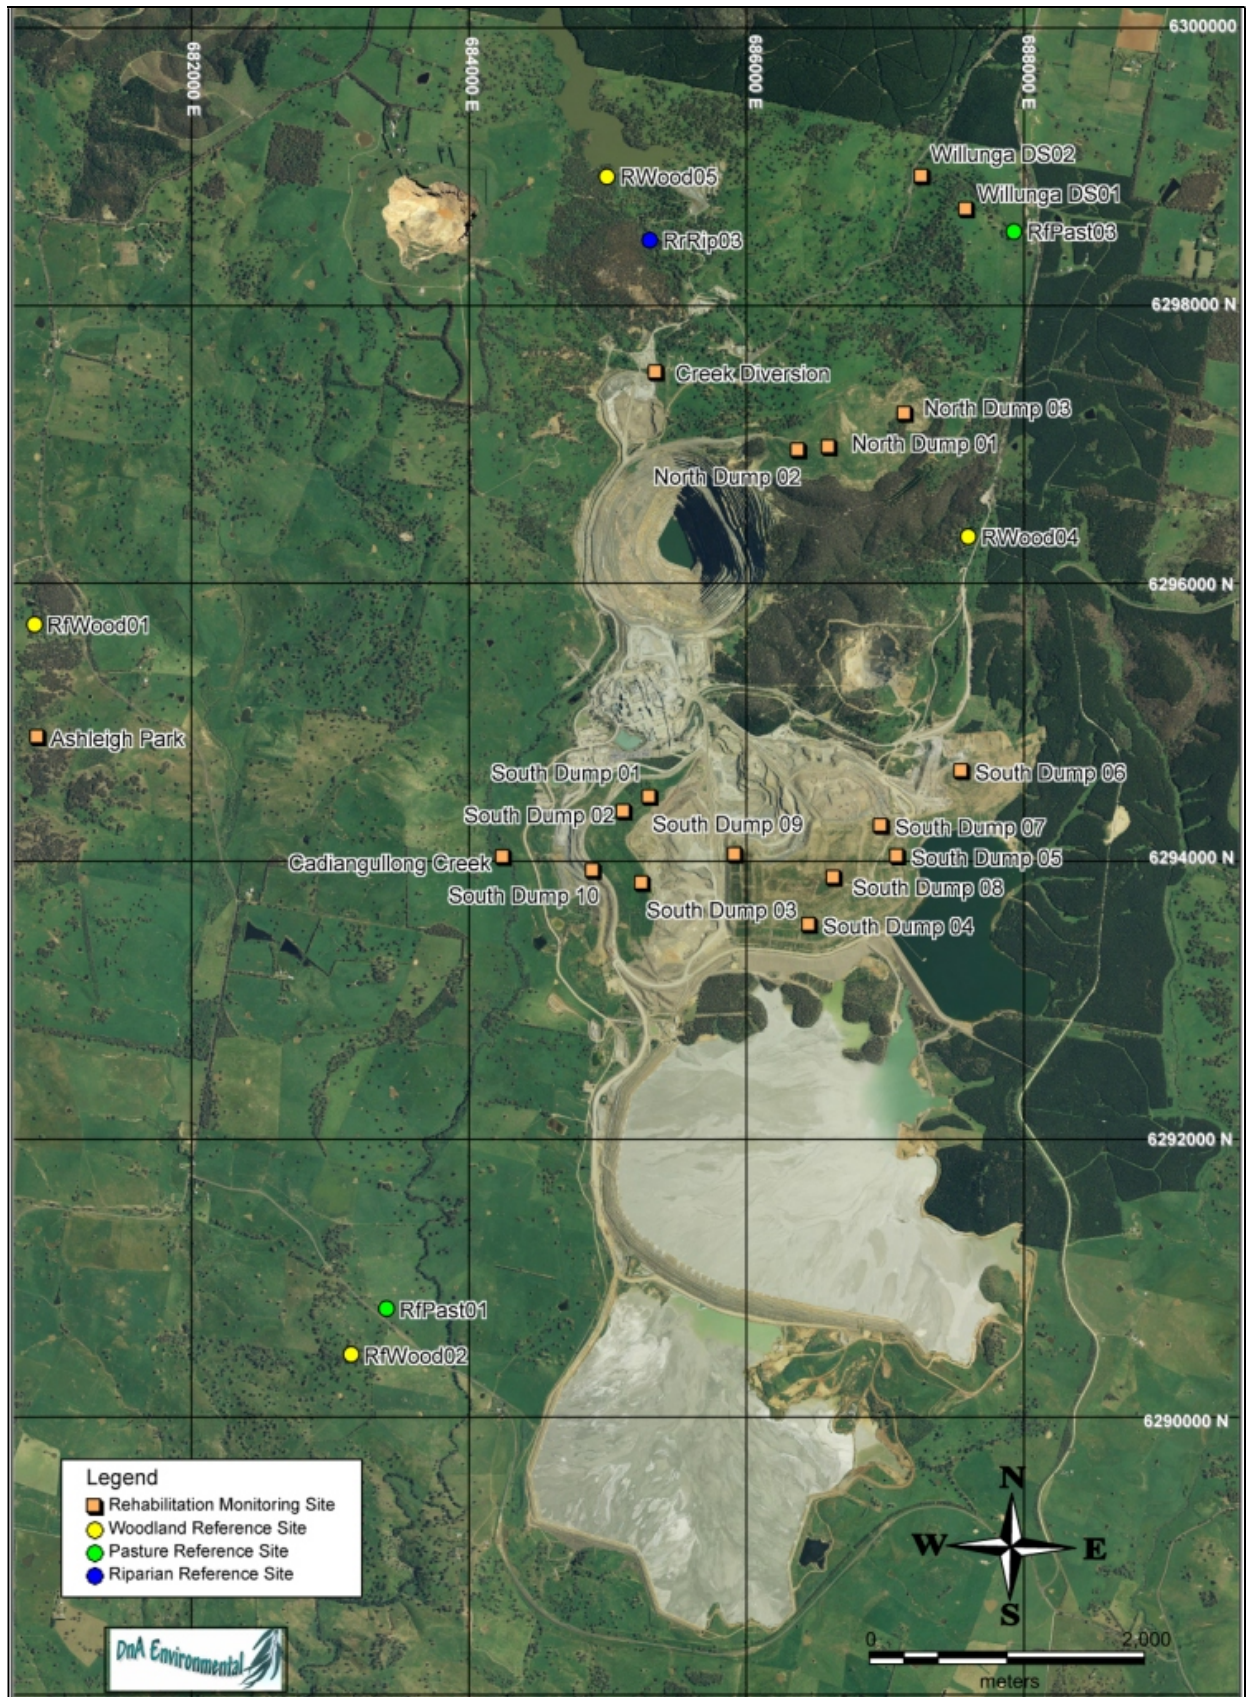
Figure 3 Location of reference and monitoring sites (as at July 2019)

Selecting suitable reference sites is essential as it will ultimately set the benchmark for rehabilitation targets and the criteria to be met for closure. Reference sites chosen for Cadia essentially include the best that could be found within the local context, and as such are a true representation of the pre-mining landscape. The reference sites were spread out where possible to maximise the spatial distribution and subsequent variations in community composition across the local landscape and are not necessarily located on Cadia property. It is acknowledged that reference sites chosen, while they are the best that could be found in a local context are still subject to impact and change due to (for example) occasional grazing, fire, drought, physical disturbance etc. The location of current reference and monitoring sites is contained in Figure 3.
