Phase 1 Preliminary Site Investigation and Report

Great Western Highway Upgrade Program -
Medlow Bath Preferred Concept Design, Detailed
Design and REF

18 December 2020

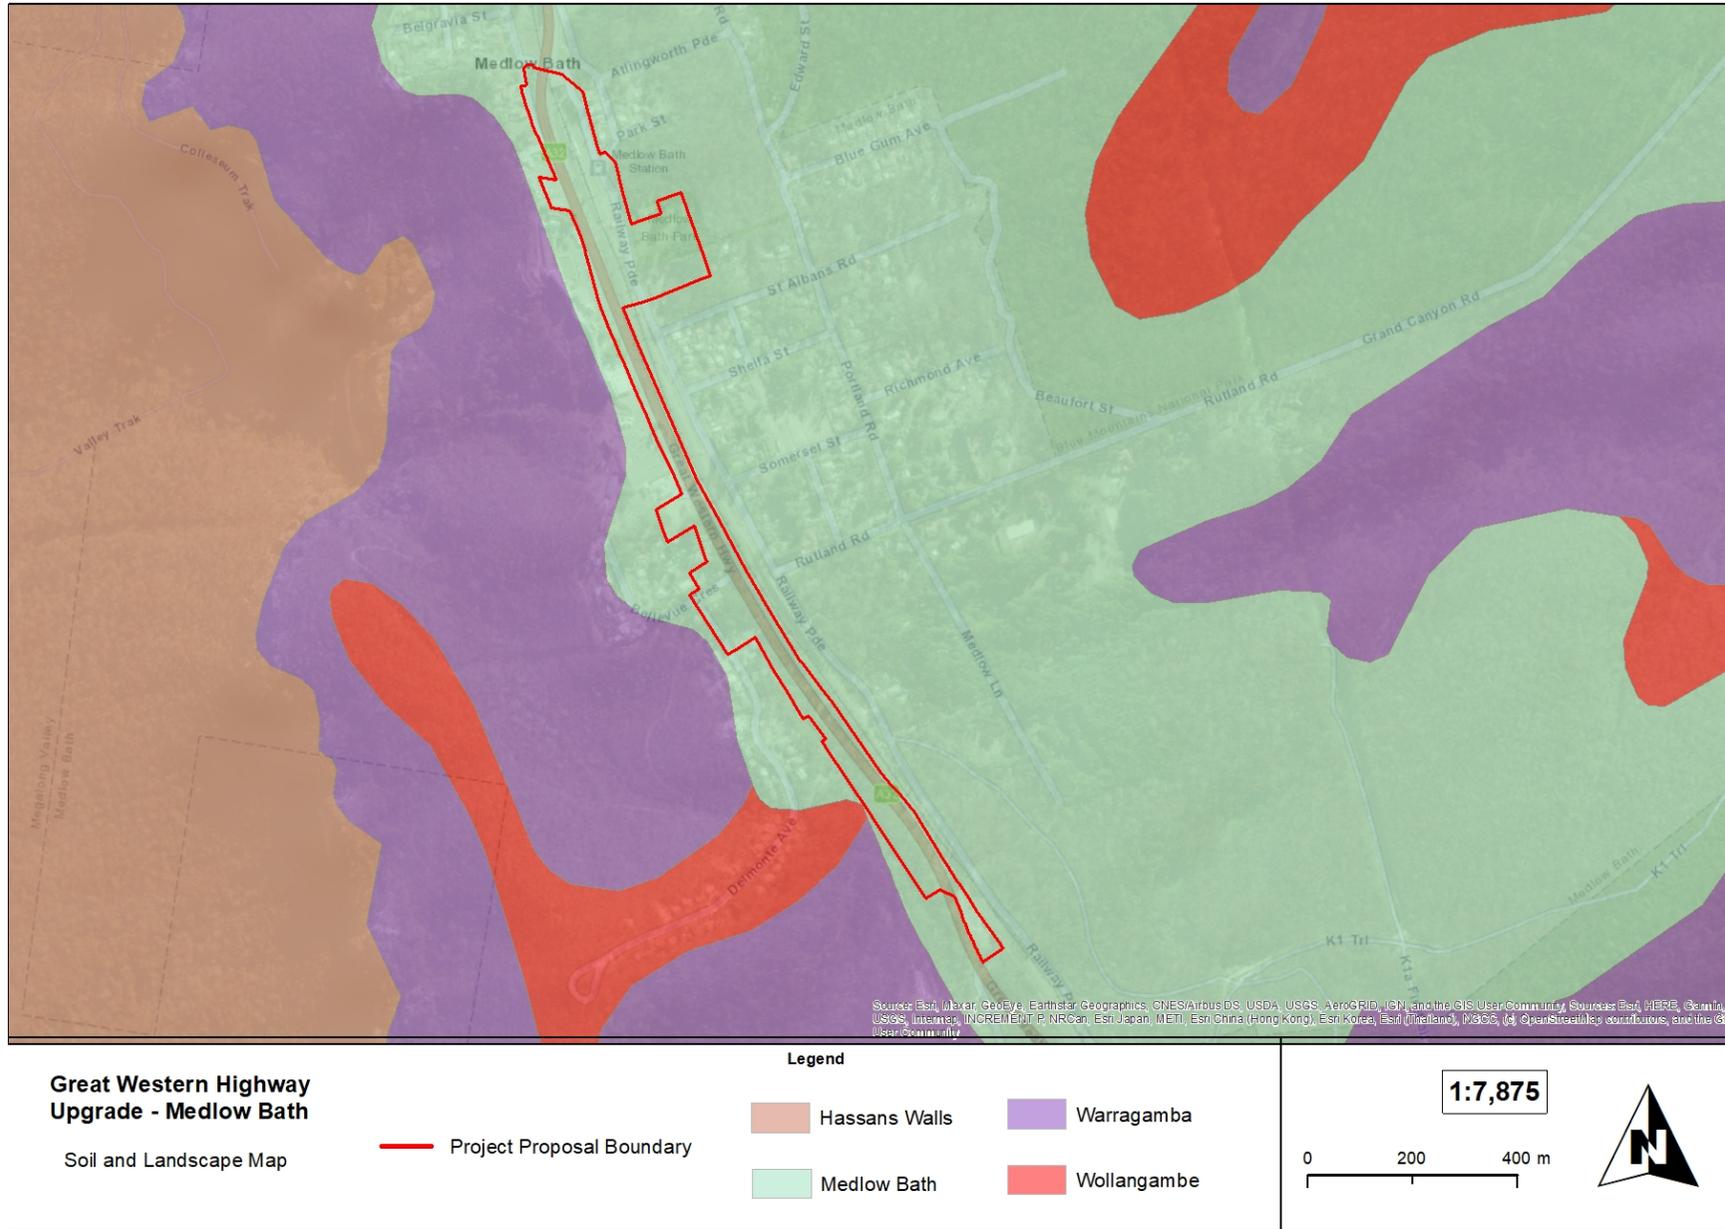
Figure 2-2: Regional geology and soil landscape

As shown in Figure 2-2 and Table 2-2, the Study area includes Medlow Bath, Warragamba, Hassans Walls and Wollangambe landscapes. Table 2-2 outlines the soil characteristics of each landscape.

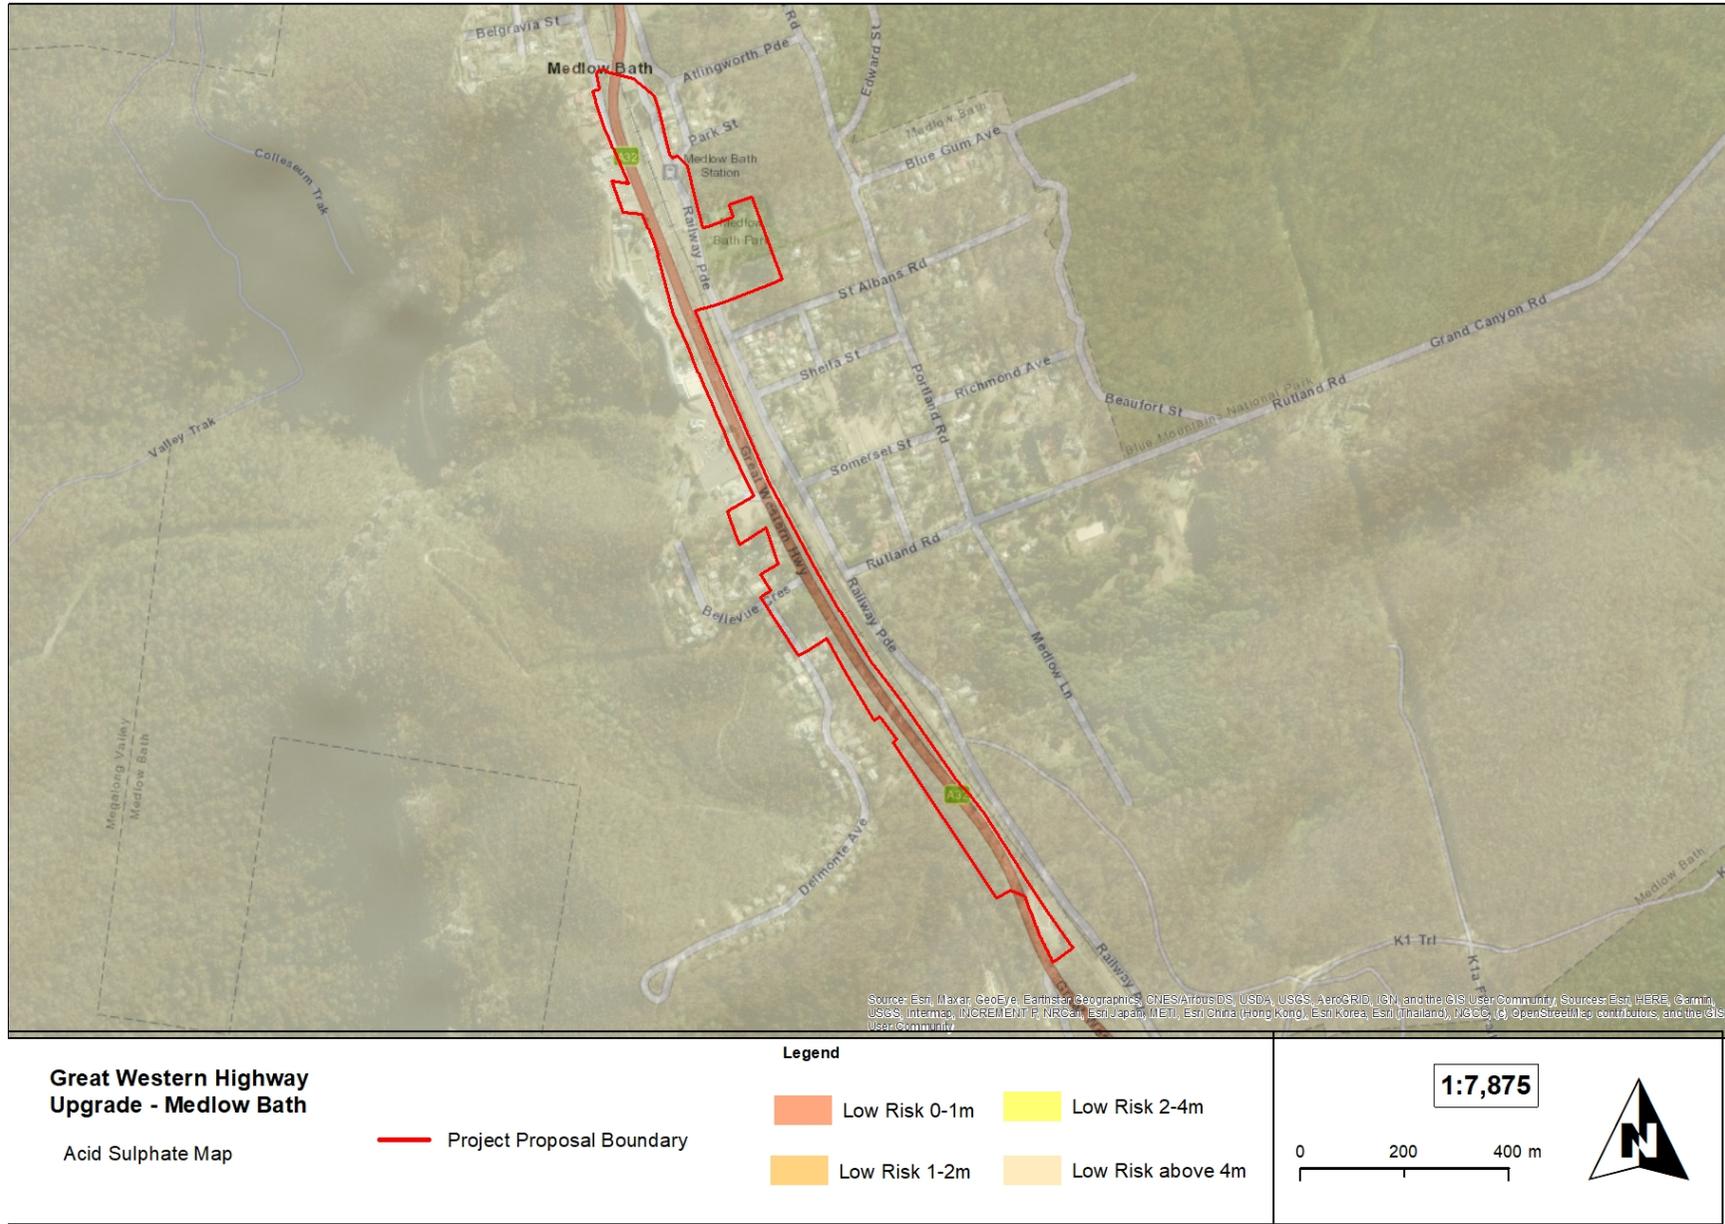
Figure 2-3 Acid sulphate soil risk

A search of the Department of Planning, Industry and Environment's database on Eastern Australian Acid Sulphate Soils (undertaken on 26 November 2020) indicates that there no known presence or risk of acid sulphate soils occurring in the vicinity of the Study area (refer to Figure 2-3).

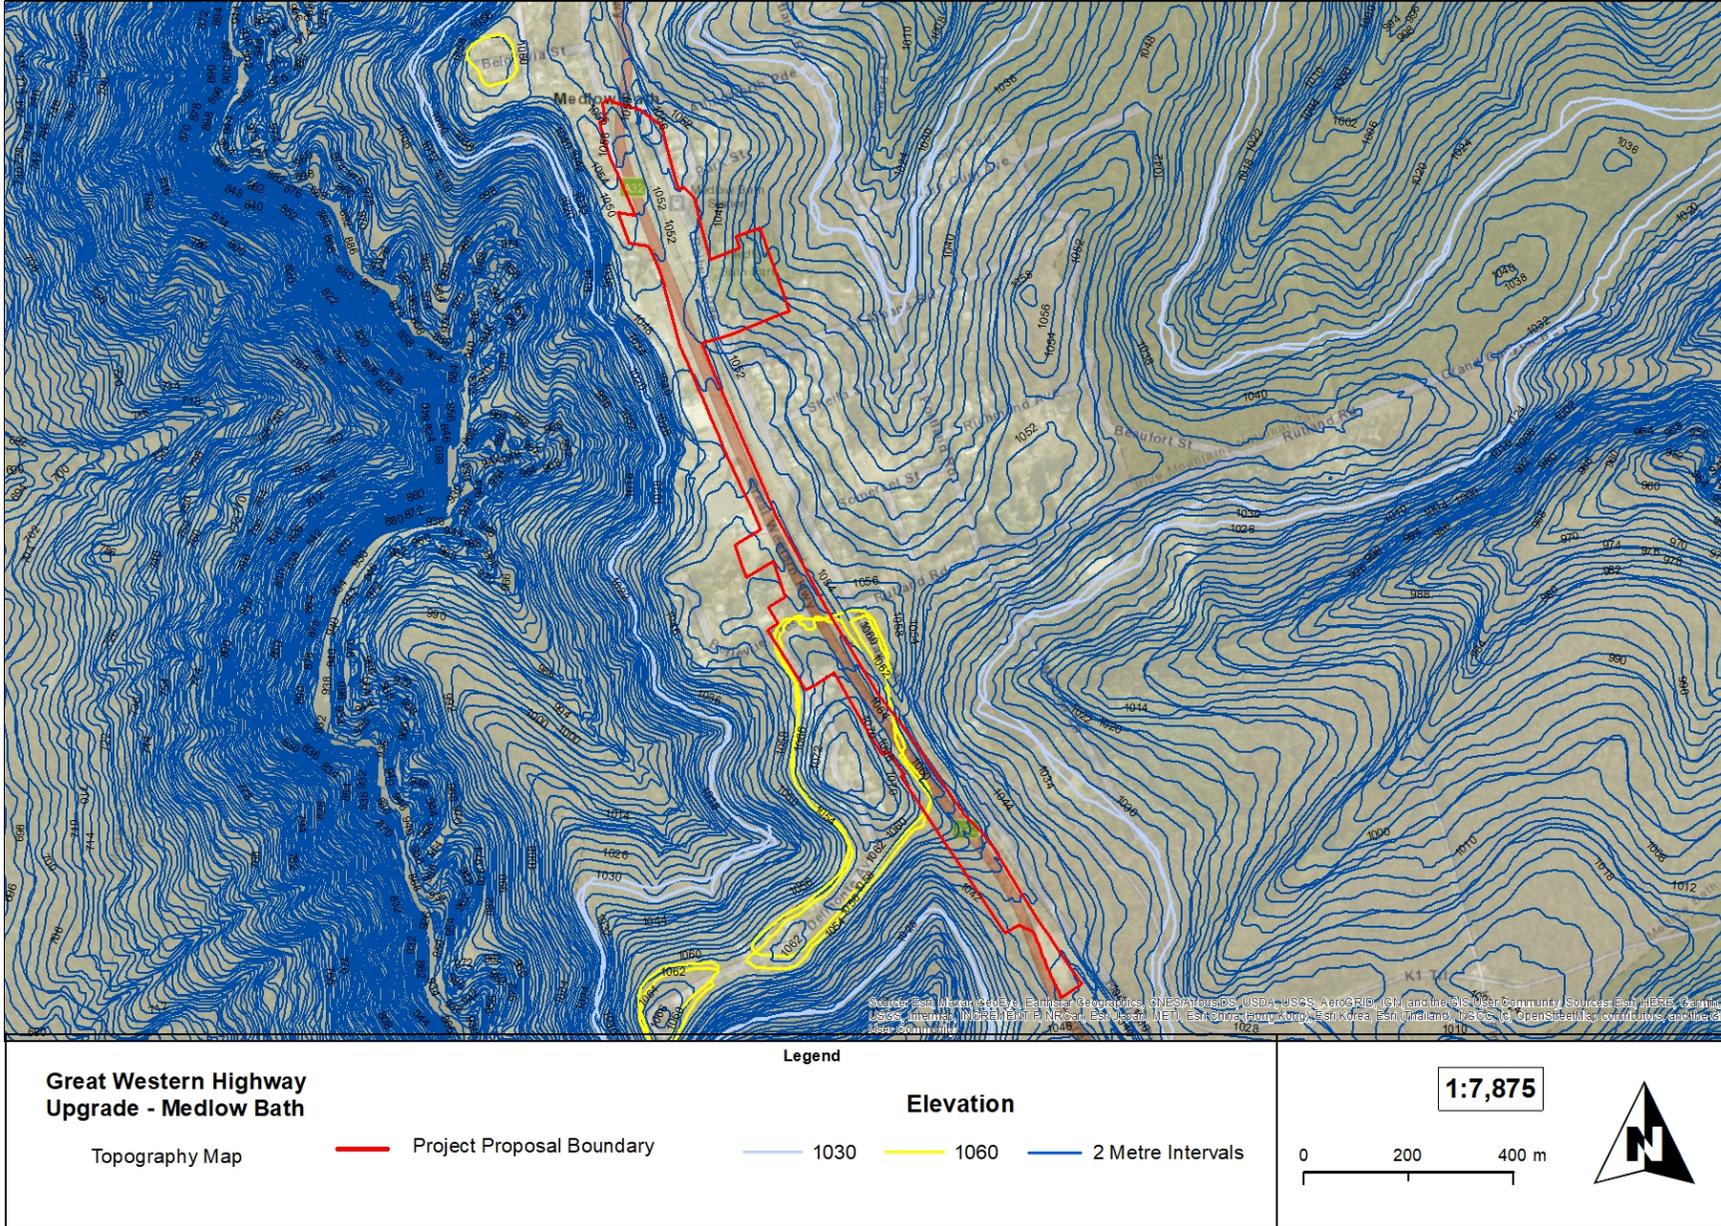
Figure 2-4: Topography

The surrounding landscape generally slopes west towards the Warragamba landscape, which greatly influences the flow of groundwater, in an area with very shallow soil depth. Figure 2-4 shows the topography of the Study area.

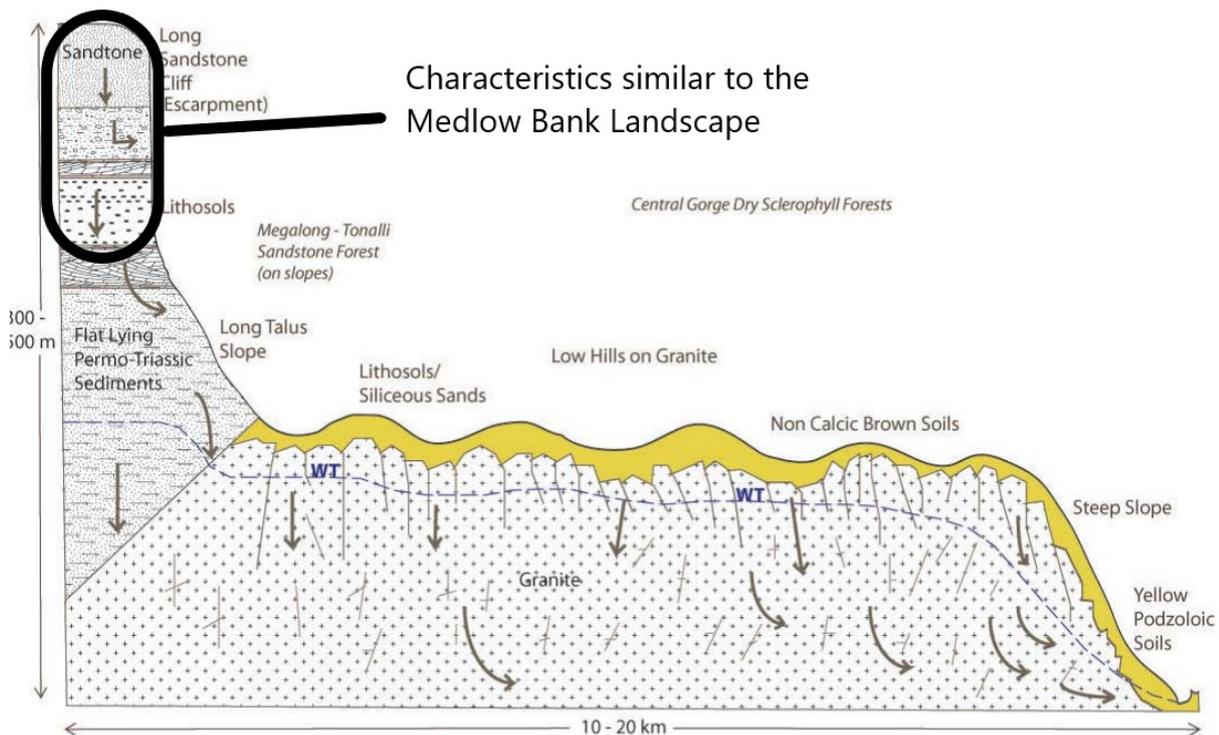
As it is noted that the Medlow Bath Landscape is that of shallow soil, and with a topography leading to a rapid cliff-like drop, it is highly likely that the groundwater flow from the Medlow Bank Landscape discharges into the lithosols/siliceous sands below the sandstone escarpment, flowing then on the surface of the granite bedrock.

Figure 2-5: Edited - Conceptual cross-section for Megalong Valley, HGL showing the distribution of; regolith landforms, salt sites and flow paths of water infiltrating the system. Source: NSW Planning, Industry and Environment.

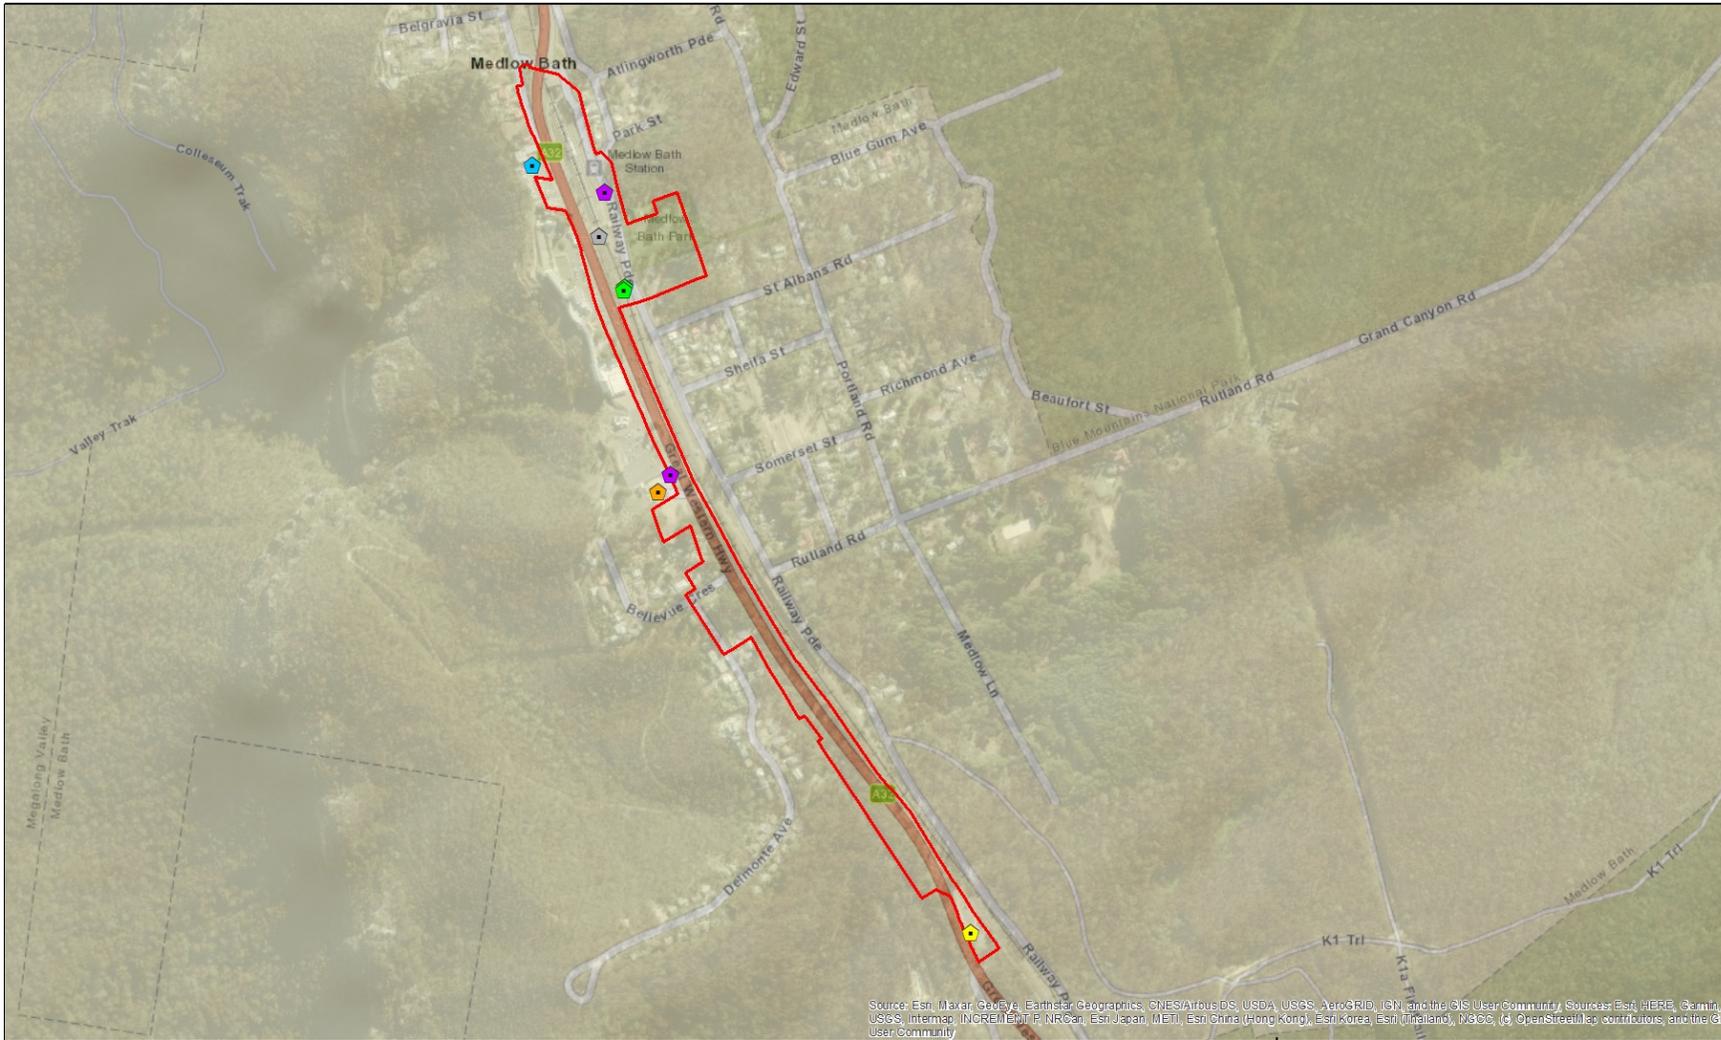
Figure 3-1 Site inspection areas of potential contamination risks

- Asbestos utility conduits were found between the Great Western Highway and the Medlow Bath Station (refer to Figure 3-1) within the study area and could occur in additional locations

Relevant site inspection photos are provided in Appendix B, Figure 3-1 shows the approximate locations of each PAEC, with Table 4-1 providing further details on each PEAC including source, exposure pathway and potential contaminants of concern.

Uncontrolled dumping of waste material was also noted within a stormwater catchment between the Great Western Highway and the Railway (as shown in Figure 3-1). Additionally, it was found that near an existing stormwater pipe that may potentially contain asbestos.

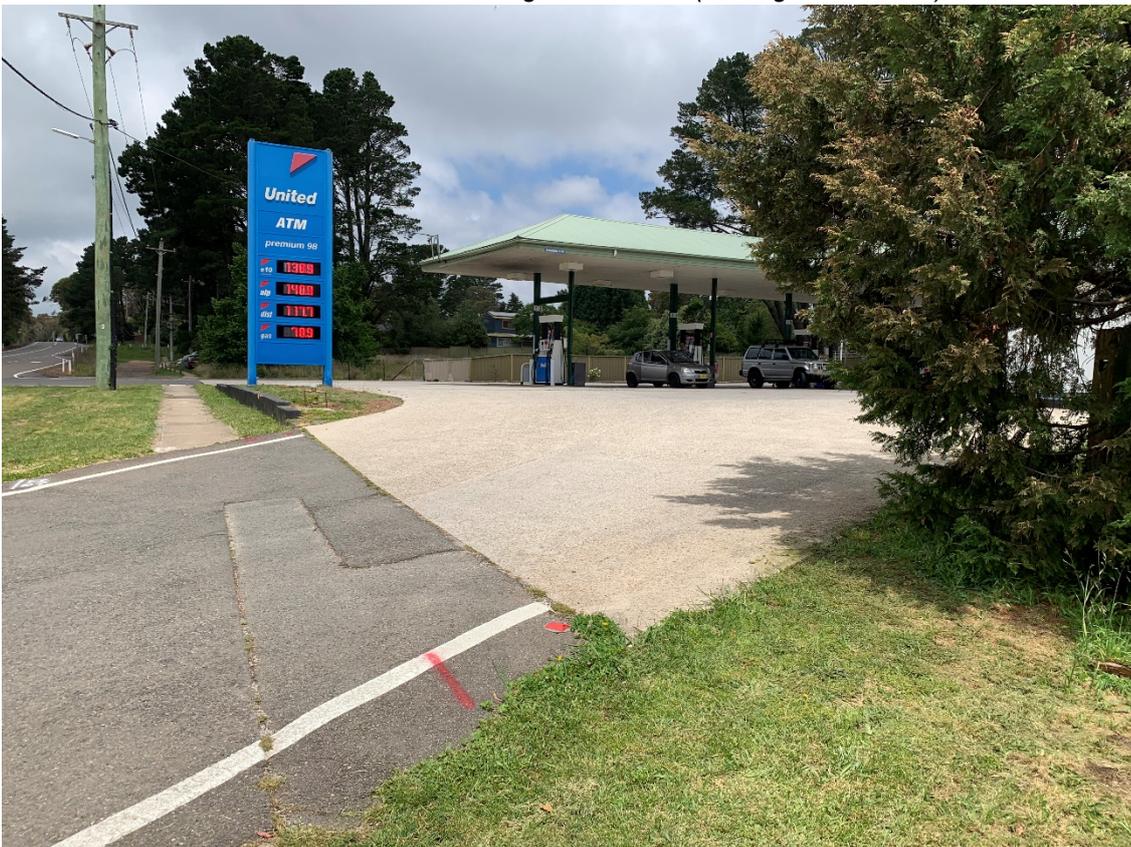
- A petrol station has existed at the address 90-92 Great Western Highway, Medlow Bath in excess of 20 years and as such there is the potential of hydrocarbon contamination from uncontrolled spills, surface water run-off and leakage from underground petroleum storage systems (previous and existing) groundwater monitoring wells were noted onsite during the site inspection

Photo 1: Petrol Station – Presence of Underground Tanks (looking South-West).

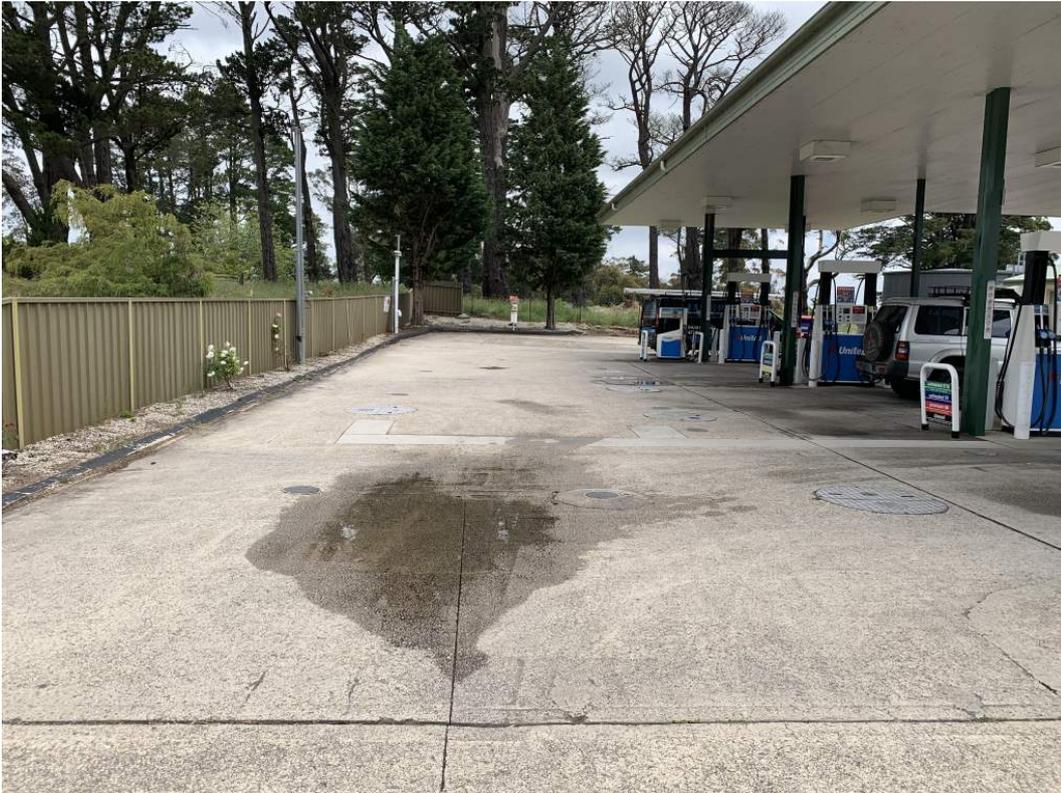
Photo 2: Petrol Station (looking West).

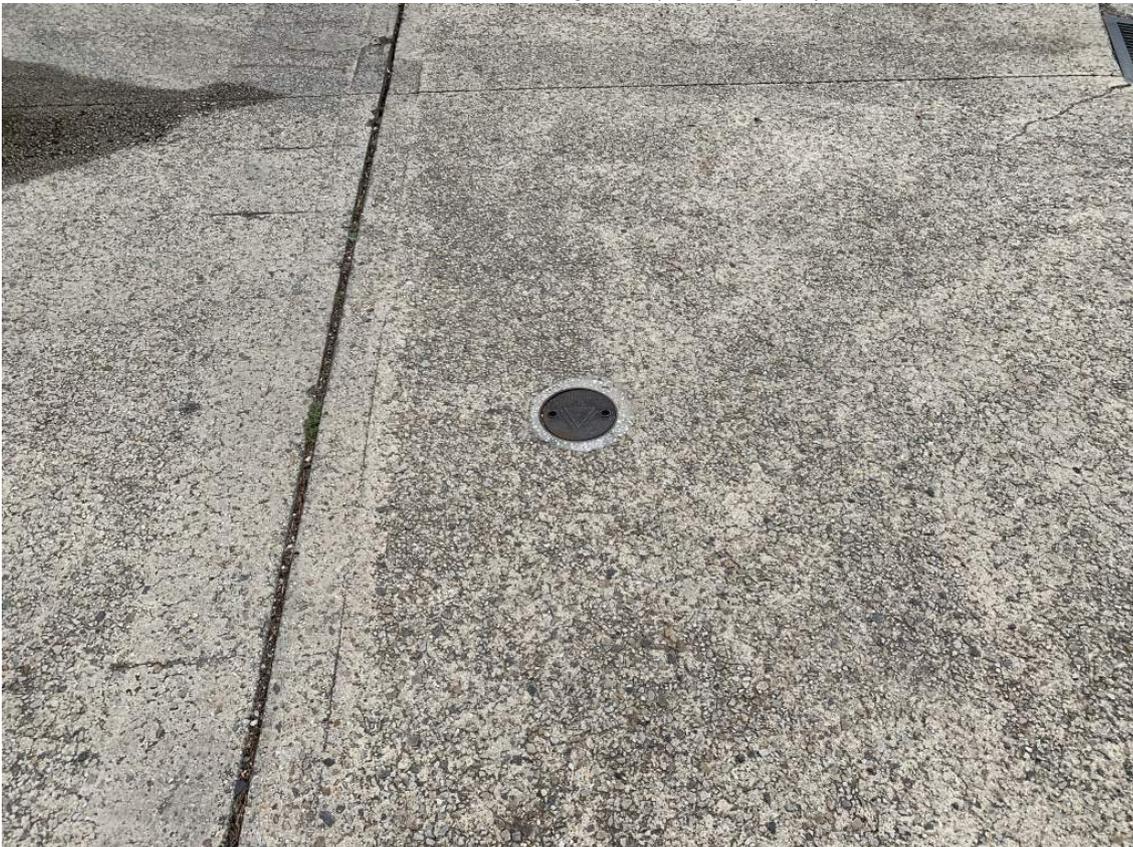
Photo 3: Petrol Station – Groundwater Monitoring Well (looking West).

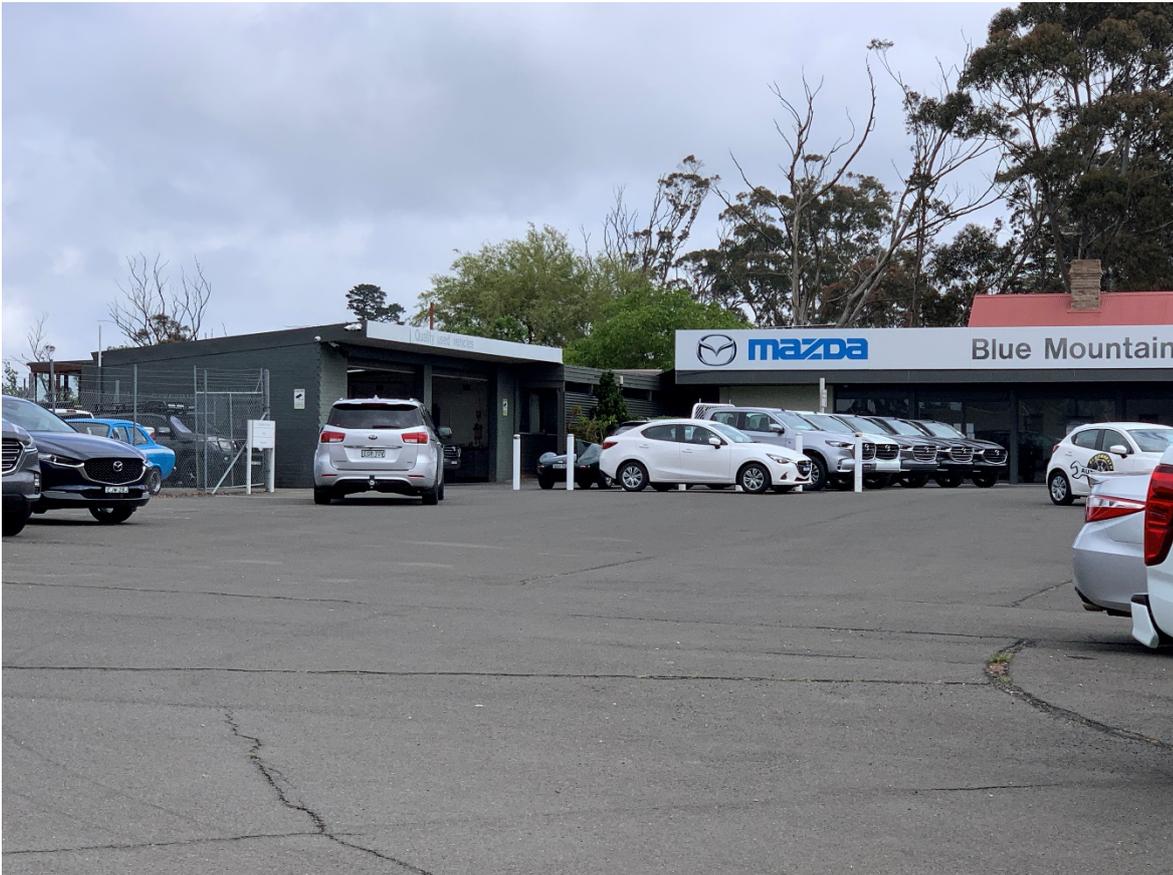
Photo 4: Car dealership with service shop on-site (looking West).

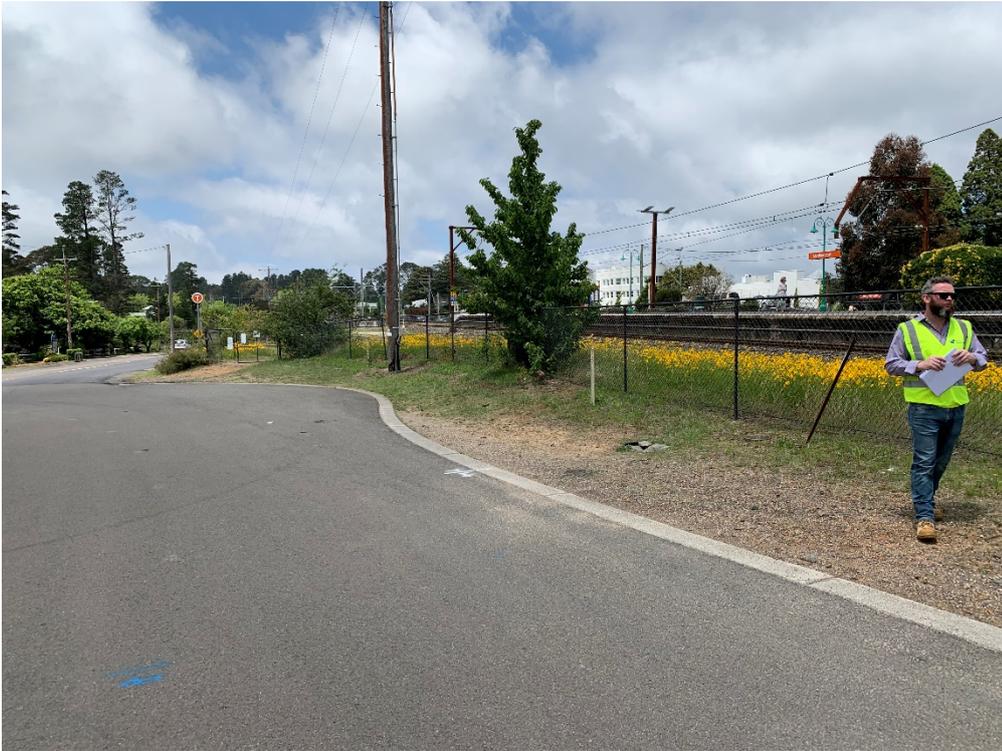
Photo 5: Evidence of fill – North-East side of Medlow Bath Station (facing South-West).

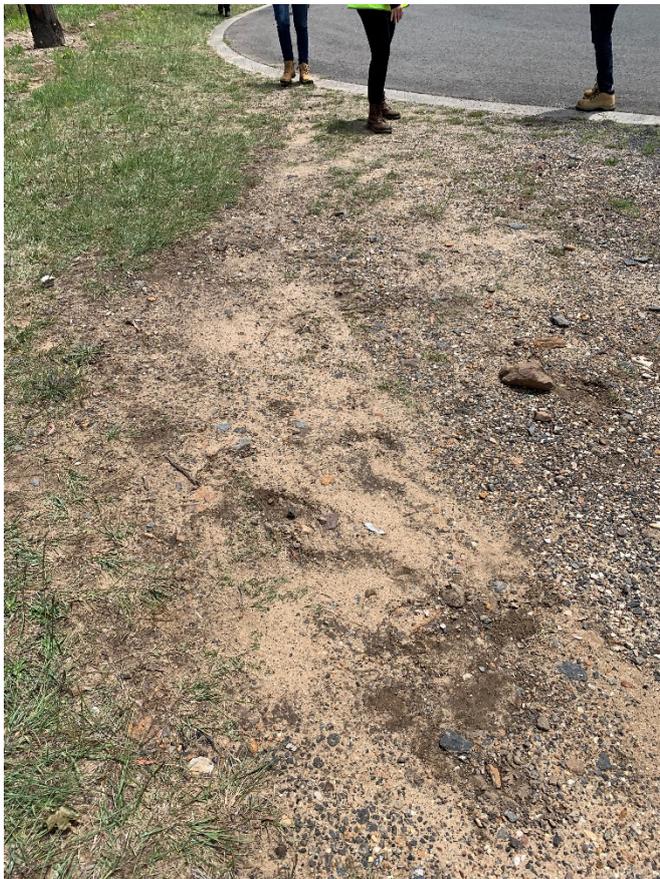
Photo 6: Evidence of fill – North-East side of Medlow Bath Station (facing South-West).

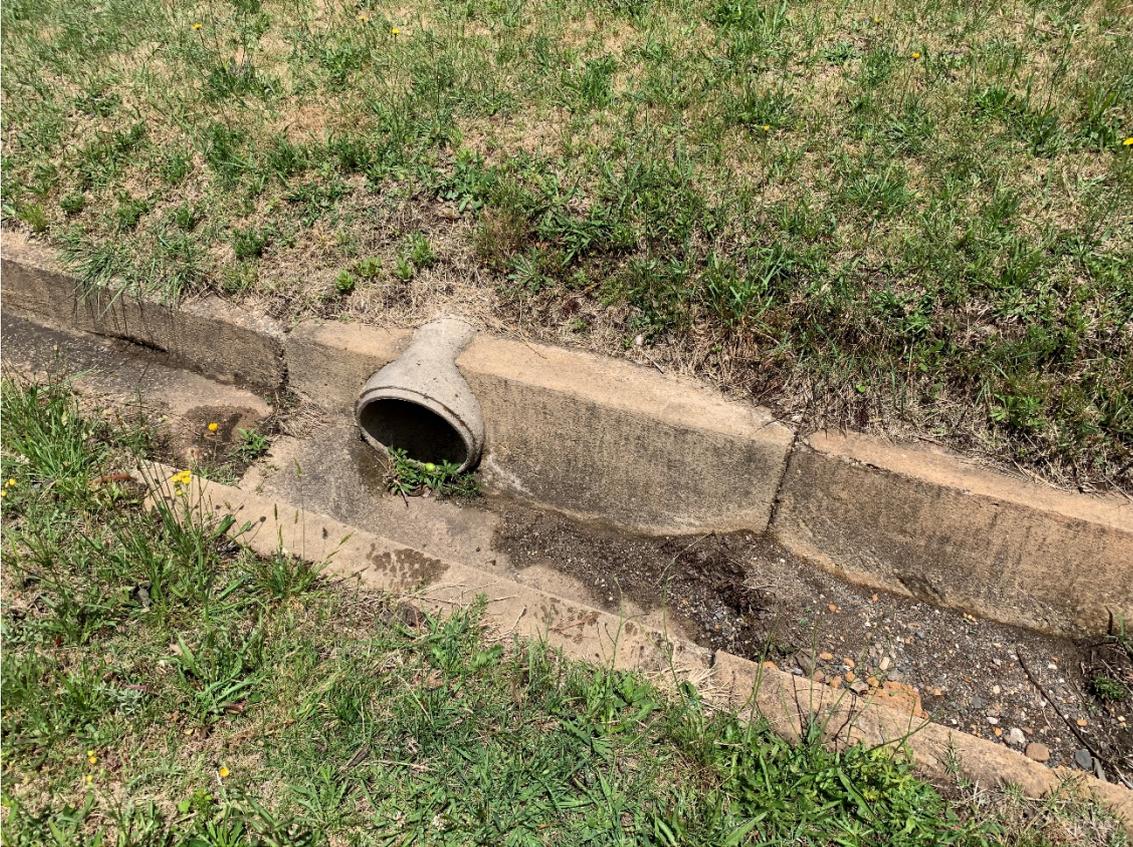
Photo 7: Evidence of fill making its way through the drainage system and conduit that potentially contains asbestos. Location is between Great Western Highway and Medlow Bath Station (looking West).

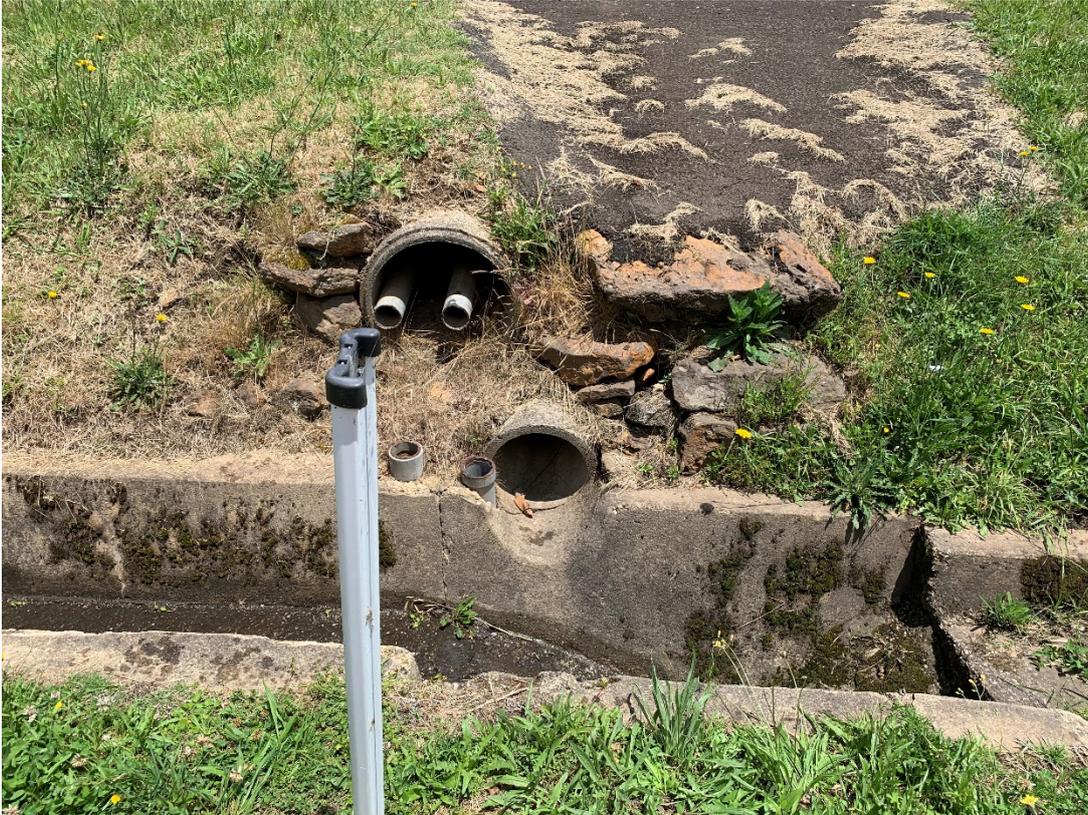
Photo 8: Example of existing stormwater pipe potentially containing asbestos (looking West)

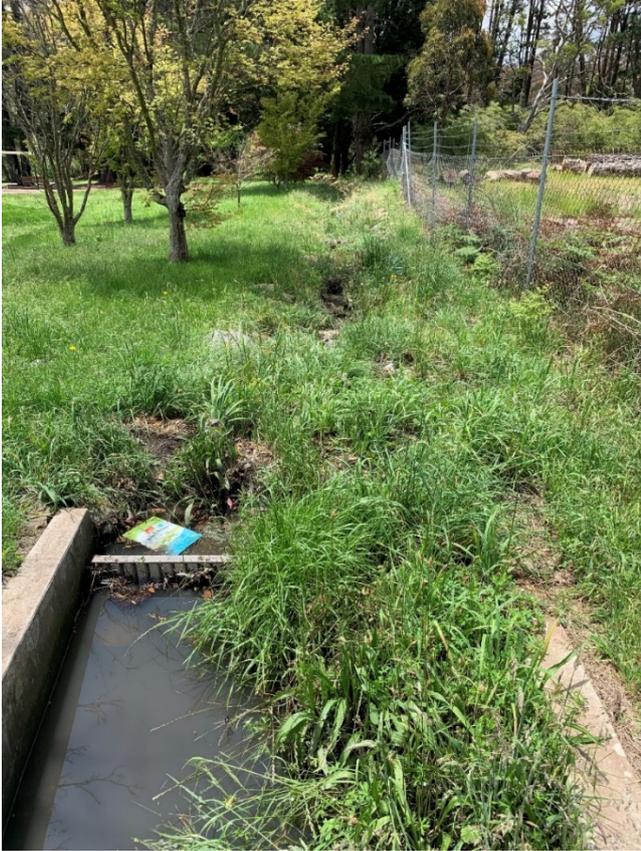
Photo 9: Uncontrolled dumping (looking South)

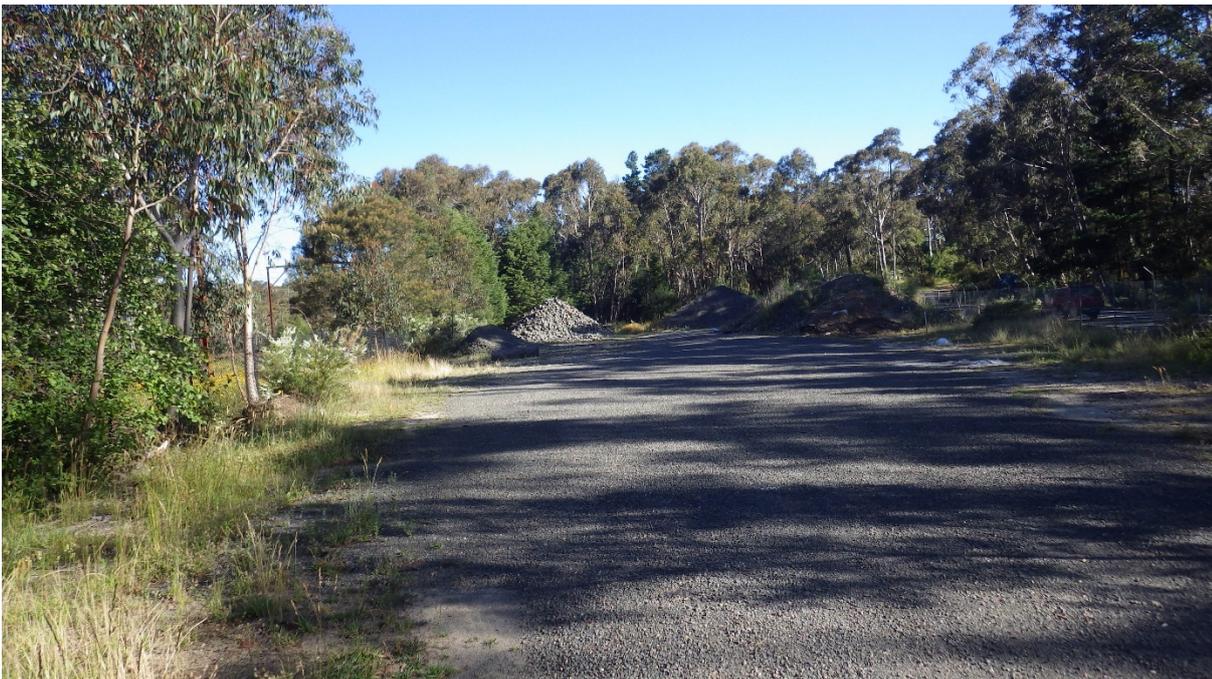
- Stockpiled ballast was observed at the compound site located at 181-183 Great Western Highway, Medlow Bath.

Vast amounts of ballast were observed at the compound site located at the address 181-183 Great Western Highway, Medlow Bath, which has been cleared of vegetation.

Photo 10: Compound Site with Stockpiled Ballast (looking South)
