6.4 Soils and contamination

This section summarises the results of a desktop investigation of the soils and geology underlying the proposal area and the *Great Western Highway Upgrade Medlow Bath Phase 1 Preliminary Site Investigation and Report* (Mott MacDonald, 2020), provided in Appendix G.

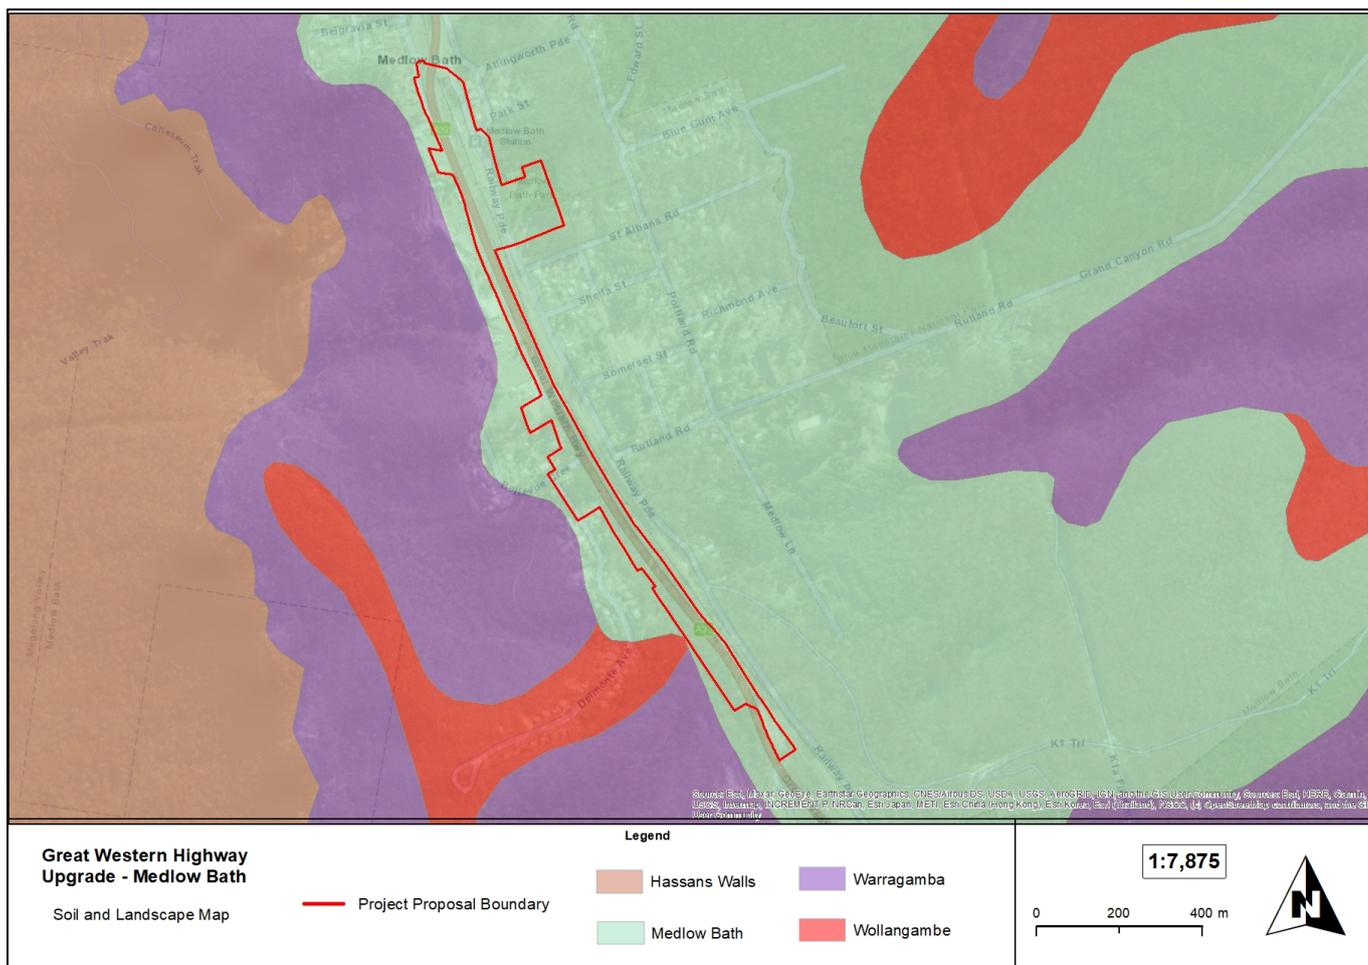
Figure 6-8: Soil landscape map for the proposal area (Source: Department of Planning, Industry and Environment)

The *1:100,000 Geology of Penrith Map* (Geological Survey of NSW, 1991), identifies the regional geology of the proposal area as a combination of the following landscape, as shown in Figure 6-8.

- **Medlow Bath (residual):** predominately a combination of Leptic Rudosols and Orthic Tenosols which are rapid to well-draining, achieving an approximate depth of 100 centimetres before bedrock.
