Cadia Annual Review 2022-2023

Surface Water Assessment

Cadia Holdings Pty Limited

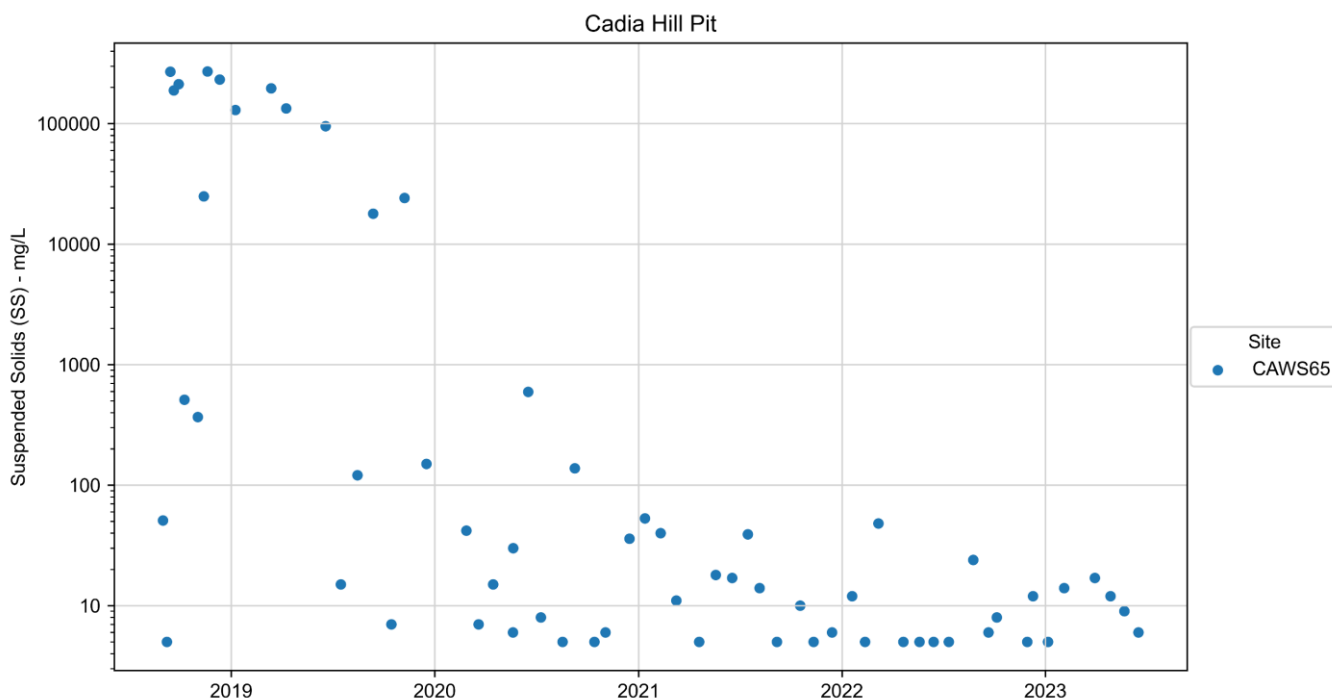
Figure 3.5 TSS concentrations in the Cadia Hill Pit decant water pond

Elevated TSS concentrations (representing suspended tailings) were observed in the pit at site CAWS65 following the initial deposition of tailings, with concentrations regularly exceeding 100 g/L up until June 2019. TSS concentrations since this time have generally reduced to concentrations less than 600 mg/L. All TSS results from 2021 to 2023 have remained below 100 mg/L, reflecting low suspended tailings in the decant water pond (Figure 3.5).

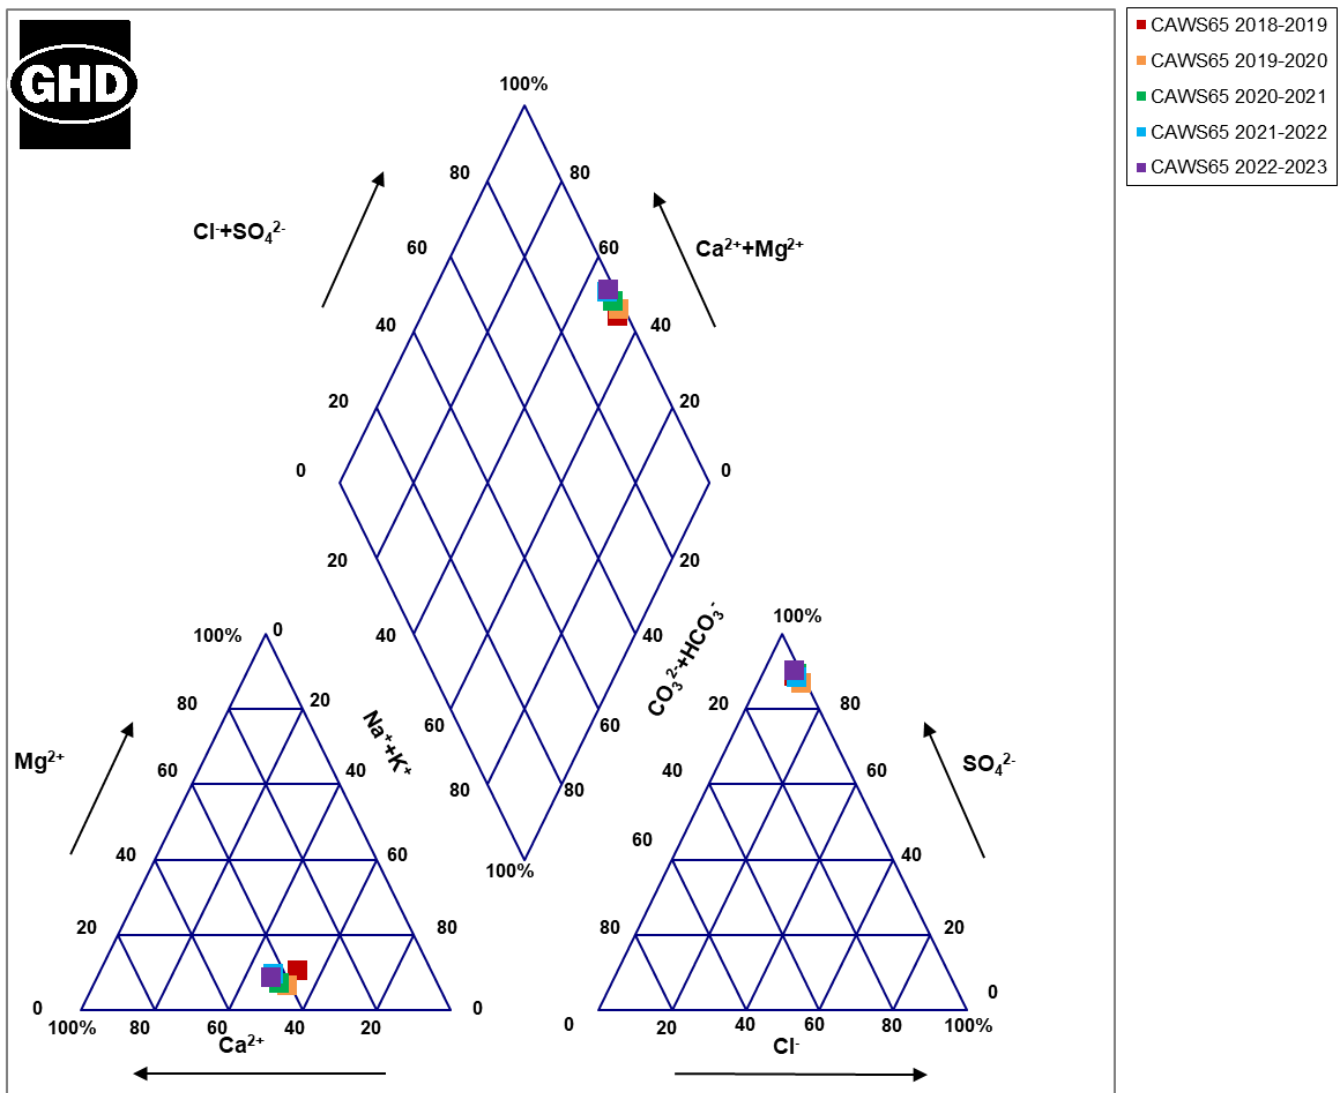
Figure 3.6 Piper chart showing differences in major ion compositions following tailings deposition

The piper plot in Figure 3.6 shows the ionic composition of the CHP during the historical monitoring periods and current reporting period, based on calculations of the median concentrations of each major ion. The ionic composition of water in the pit has remained consistent over time, with a mixed sodium/calcium cation dominance and sulfate the dominant anion. Sodium sulfate dominance is consistent with historical tailings water quality at CVO.

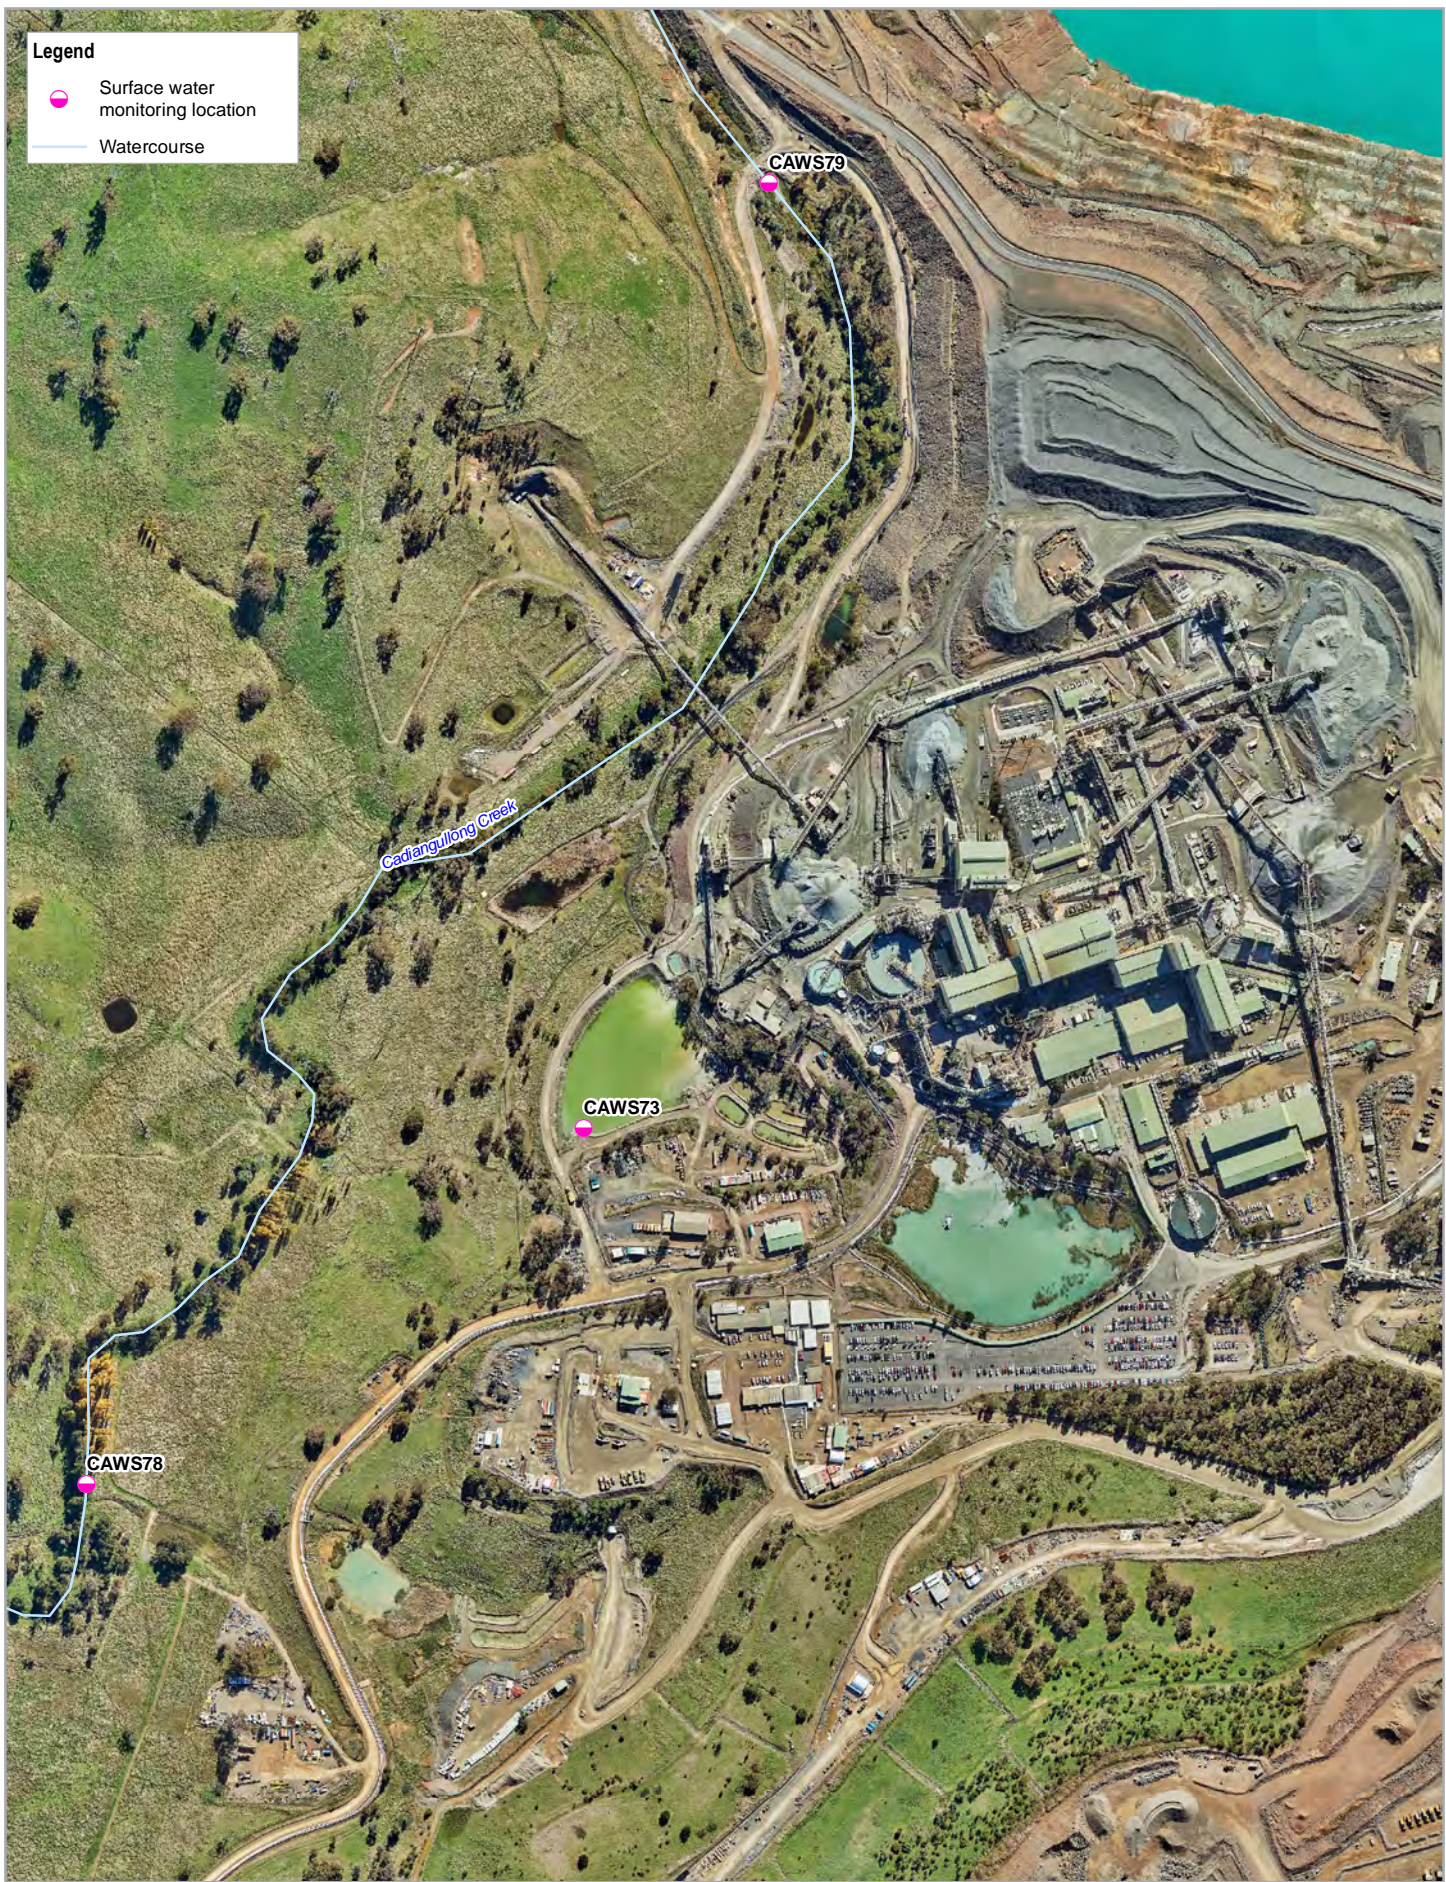
Surface water is monitored at the following sites, as shown in Figure 3.8:

- Watercourses: CAWS79, CAWS78
- Surface water storages: CAWS73

The SROP (CAWS73) is a zero-discharge stormwater runoff dam. The SROP is clay lined and captures site runoff and leakage from the processing plant. CAWS79 (background monitoring location) and CAWS78 (impact monitoring location) are sampled to assess the quality of water in Cadiangullong Creek prior to the zone of influence, and immediately downstream of the zone of influence, respectively.

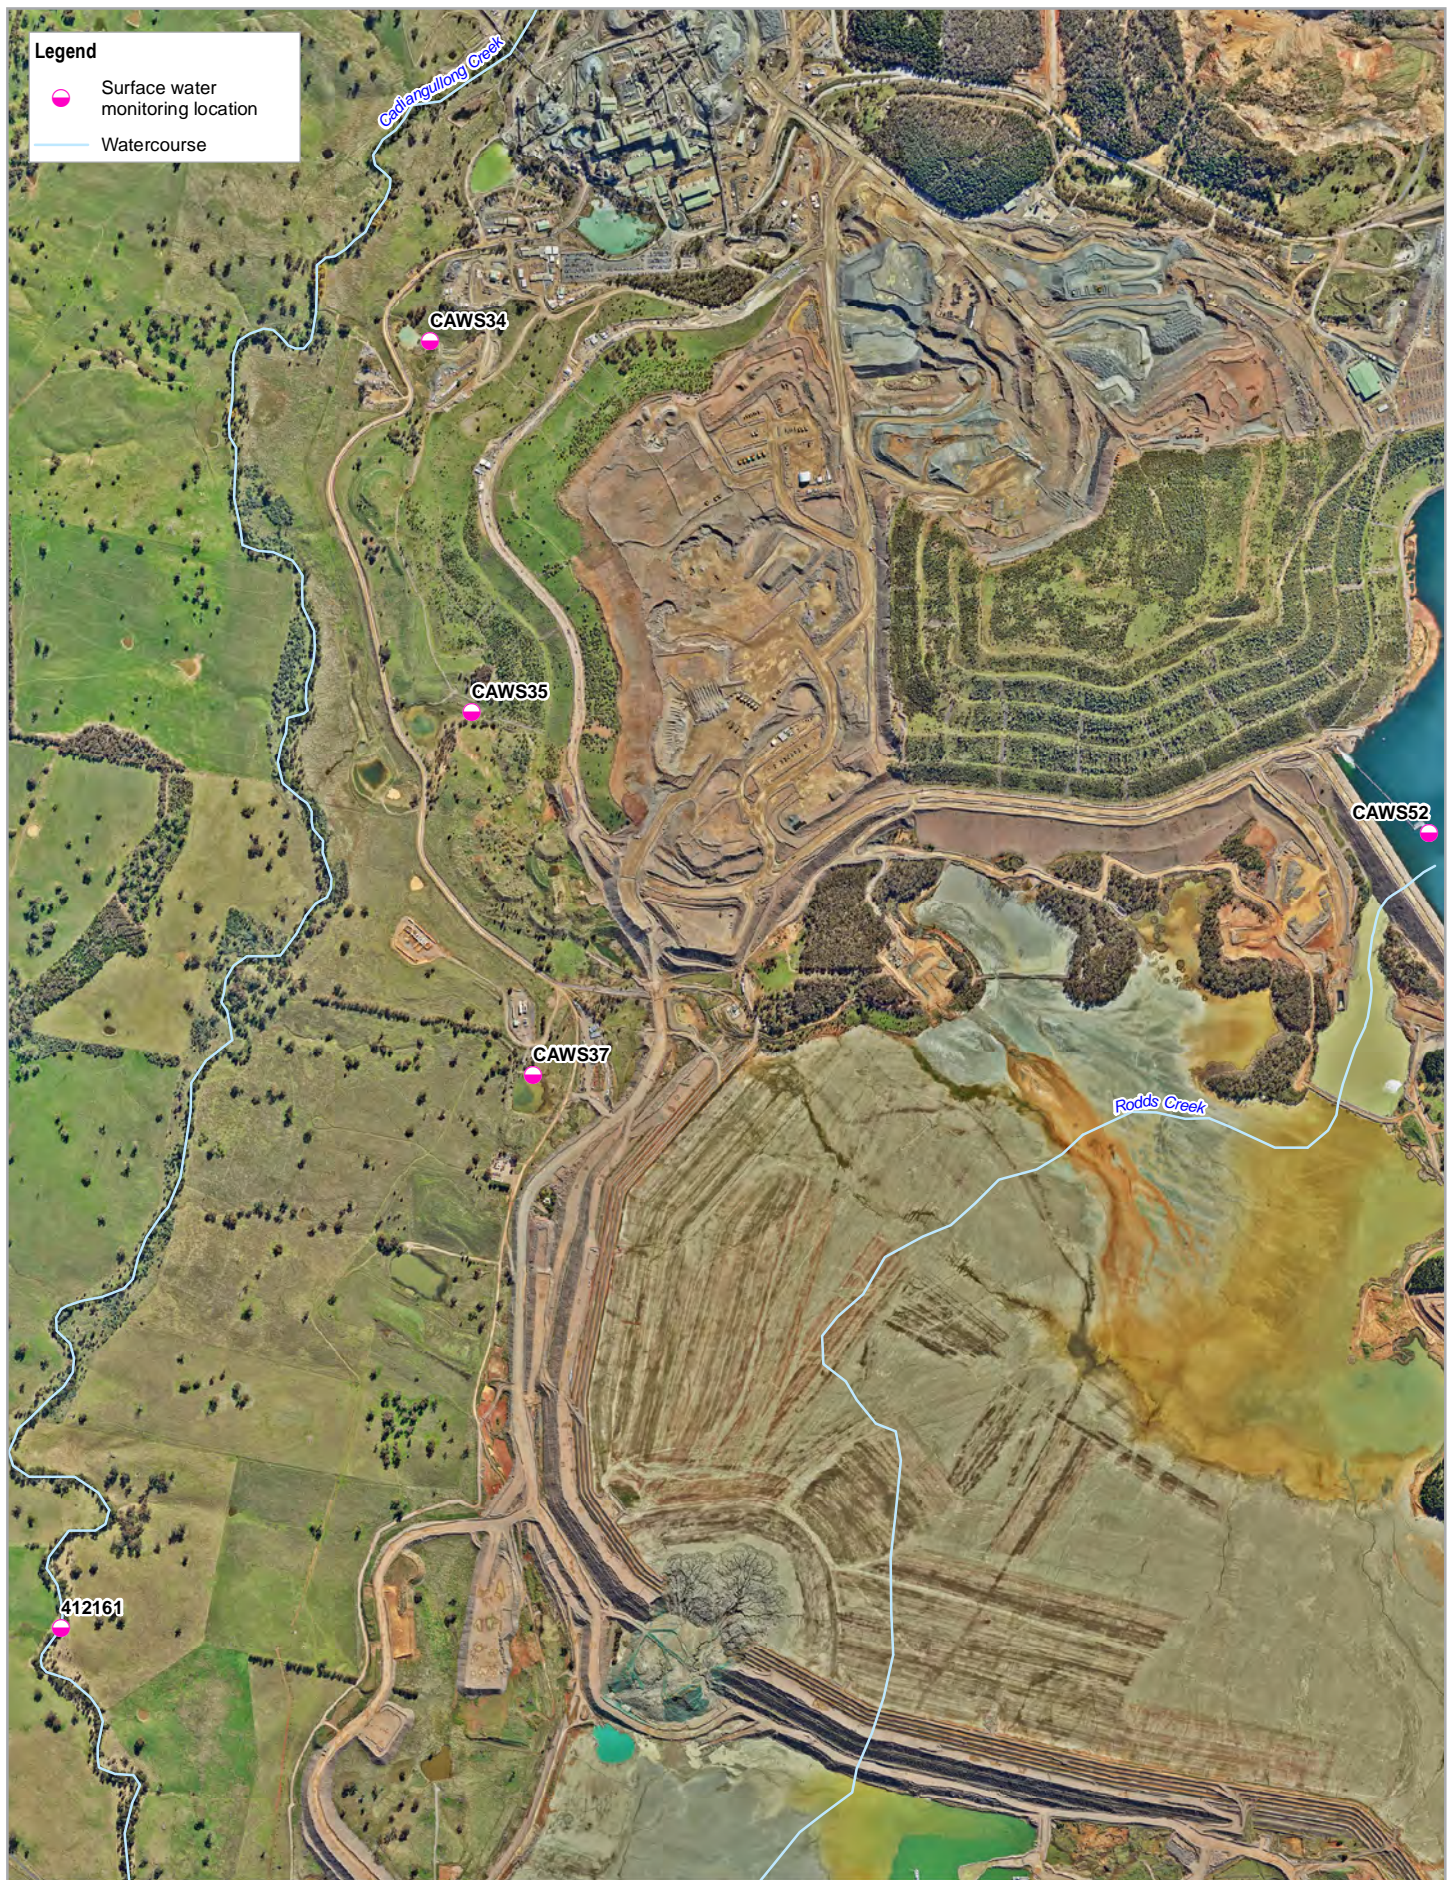
Surface water is monitored at the following Waste Rock Dump sites, as shown in Figure 3.12:

The nearest downstream Cadiangullong Creek site is 412161, which is the potential receptor for any impact of the SWRDs on surface water quality.

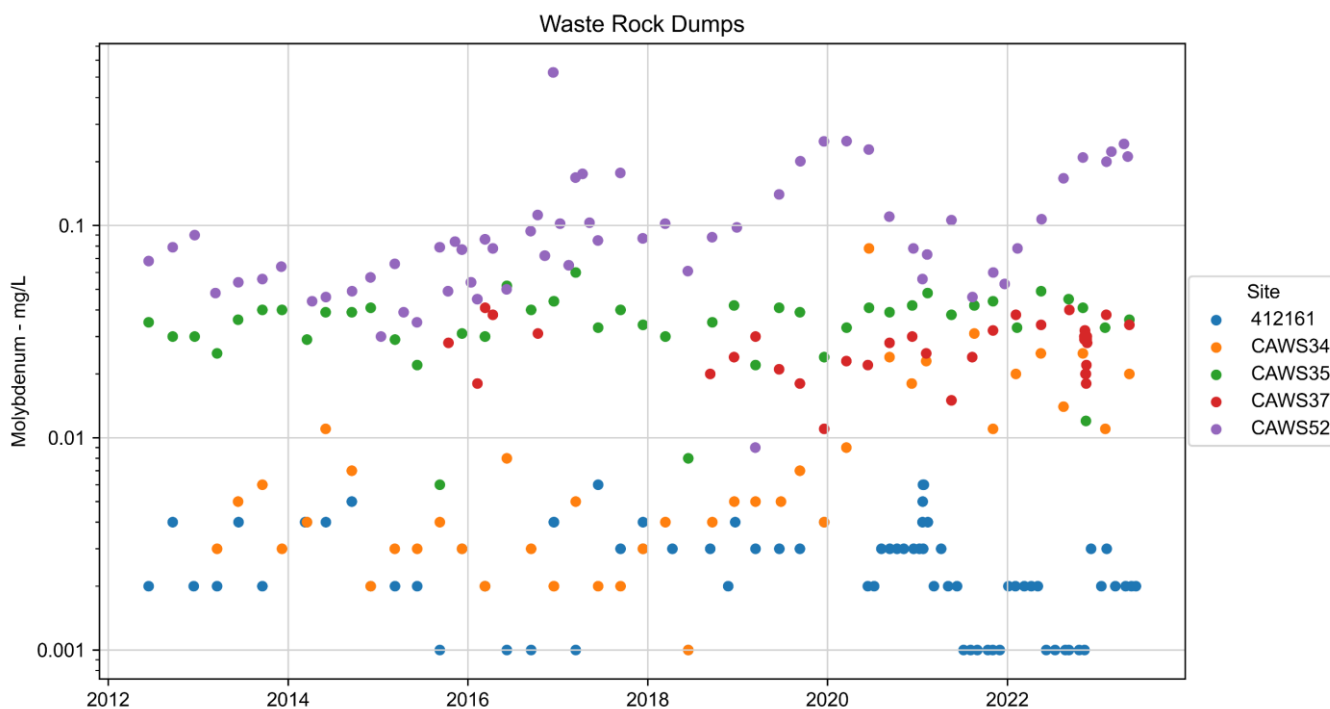
Figure 3.17 Molybdenum concentrations in the Waste Rock Dumps area

Molybdenum concentrations have remained steady at CAWS35 and CAWS37 over the history of the monitoring period (Figure 3.17). Molybdenum concentrations at CAWS34 were historically lower than those at CAWS35 and CAWS37 and were frequently observed in concentrations similar to those at 412161. However, from 2020 to 2023, molybdenum concentrations at CAWS34 have increased and are similar to observed concentrations at CAWS35 and CAWS37. Molybdenum concentrations have been higher at CAWS52 than at the leachate dams, which, considering that molybdenum is associated with the ore mined at CVO, indicates the influence of tailings decant water pumped to Rodds Creek Dam from the NTSF in times of increased rainfall. The CAWS52 molybdenum results showed an increasing trend between 2013 and 2020, before decreasing from 2020 to 2022, and again increasing during 2022 and 2023.

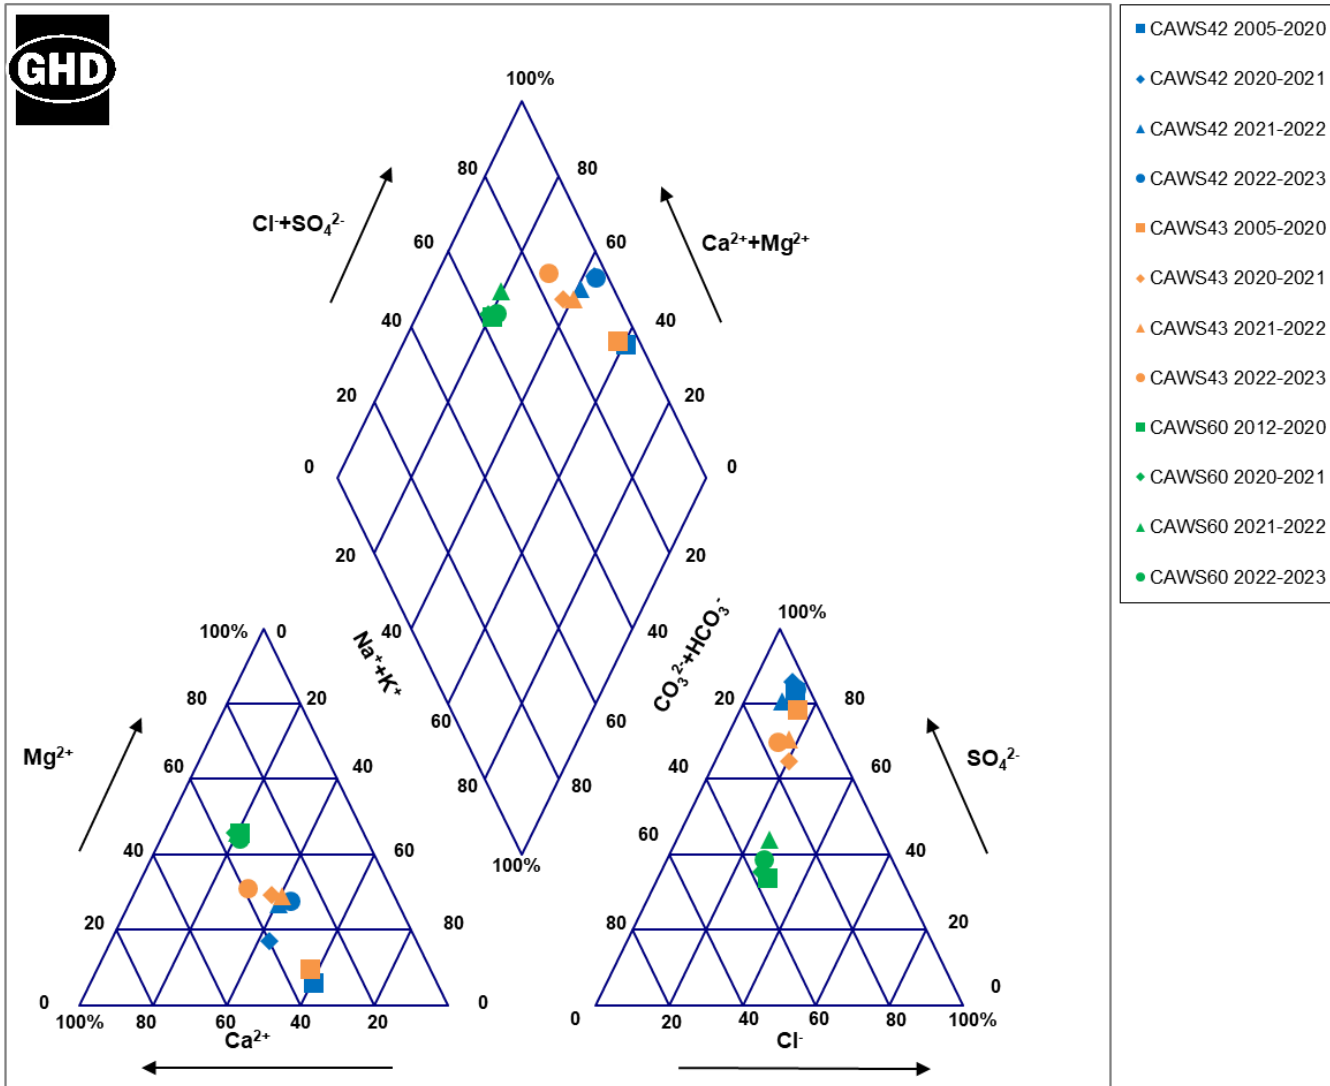
Figure 3.21 Piper chart showing differences in major ion composition at TSF Eastern Zone sites

The piper plot in Figure 3.21 shows the ionic composition of TSF Eastern sites during the historical monitoring periods and current reporting period, based on calculations of the median concentrations of each major ion. The piper chart shows that the tailings decant pond water (CAWS42 and CAWS43) is ionically dissimilar to the dyke pond (CAWS60). The TSF decant water was sodium sulfate dominant, though with a stronger dominance of the magnesium ion during more recent sampling events, while the dyke pond shows a mixed ionic composition.

There was a stronger dominance of the sulfate anion at CAWS42 than at CAWS43, while cation composition of the water at these two sites is more similar between sampling events than within sites.

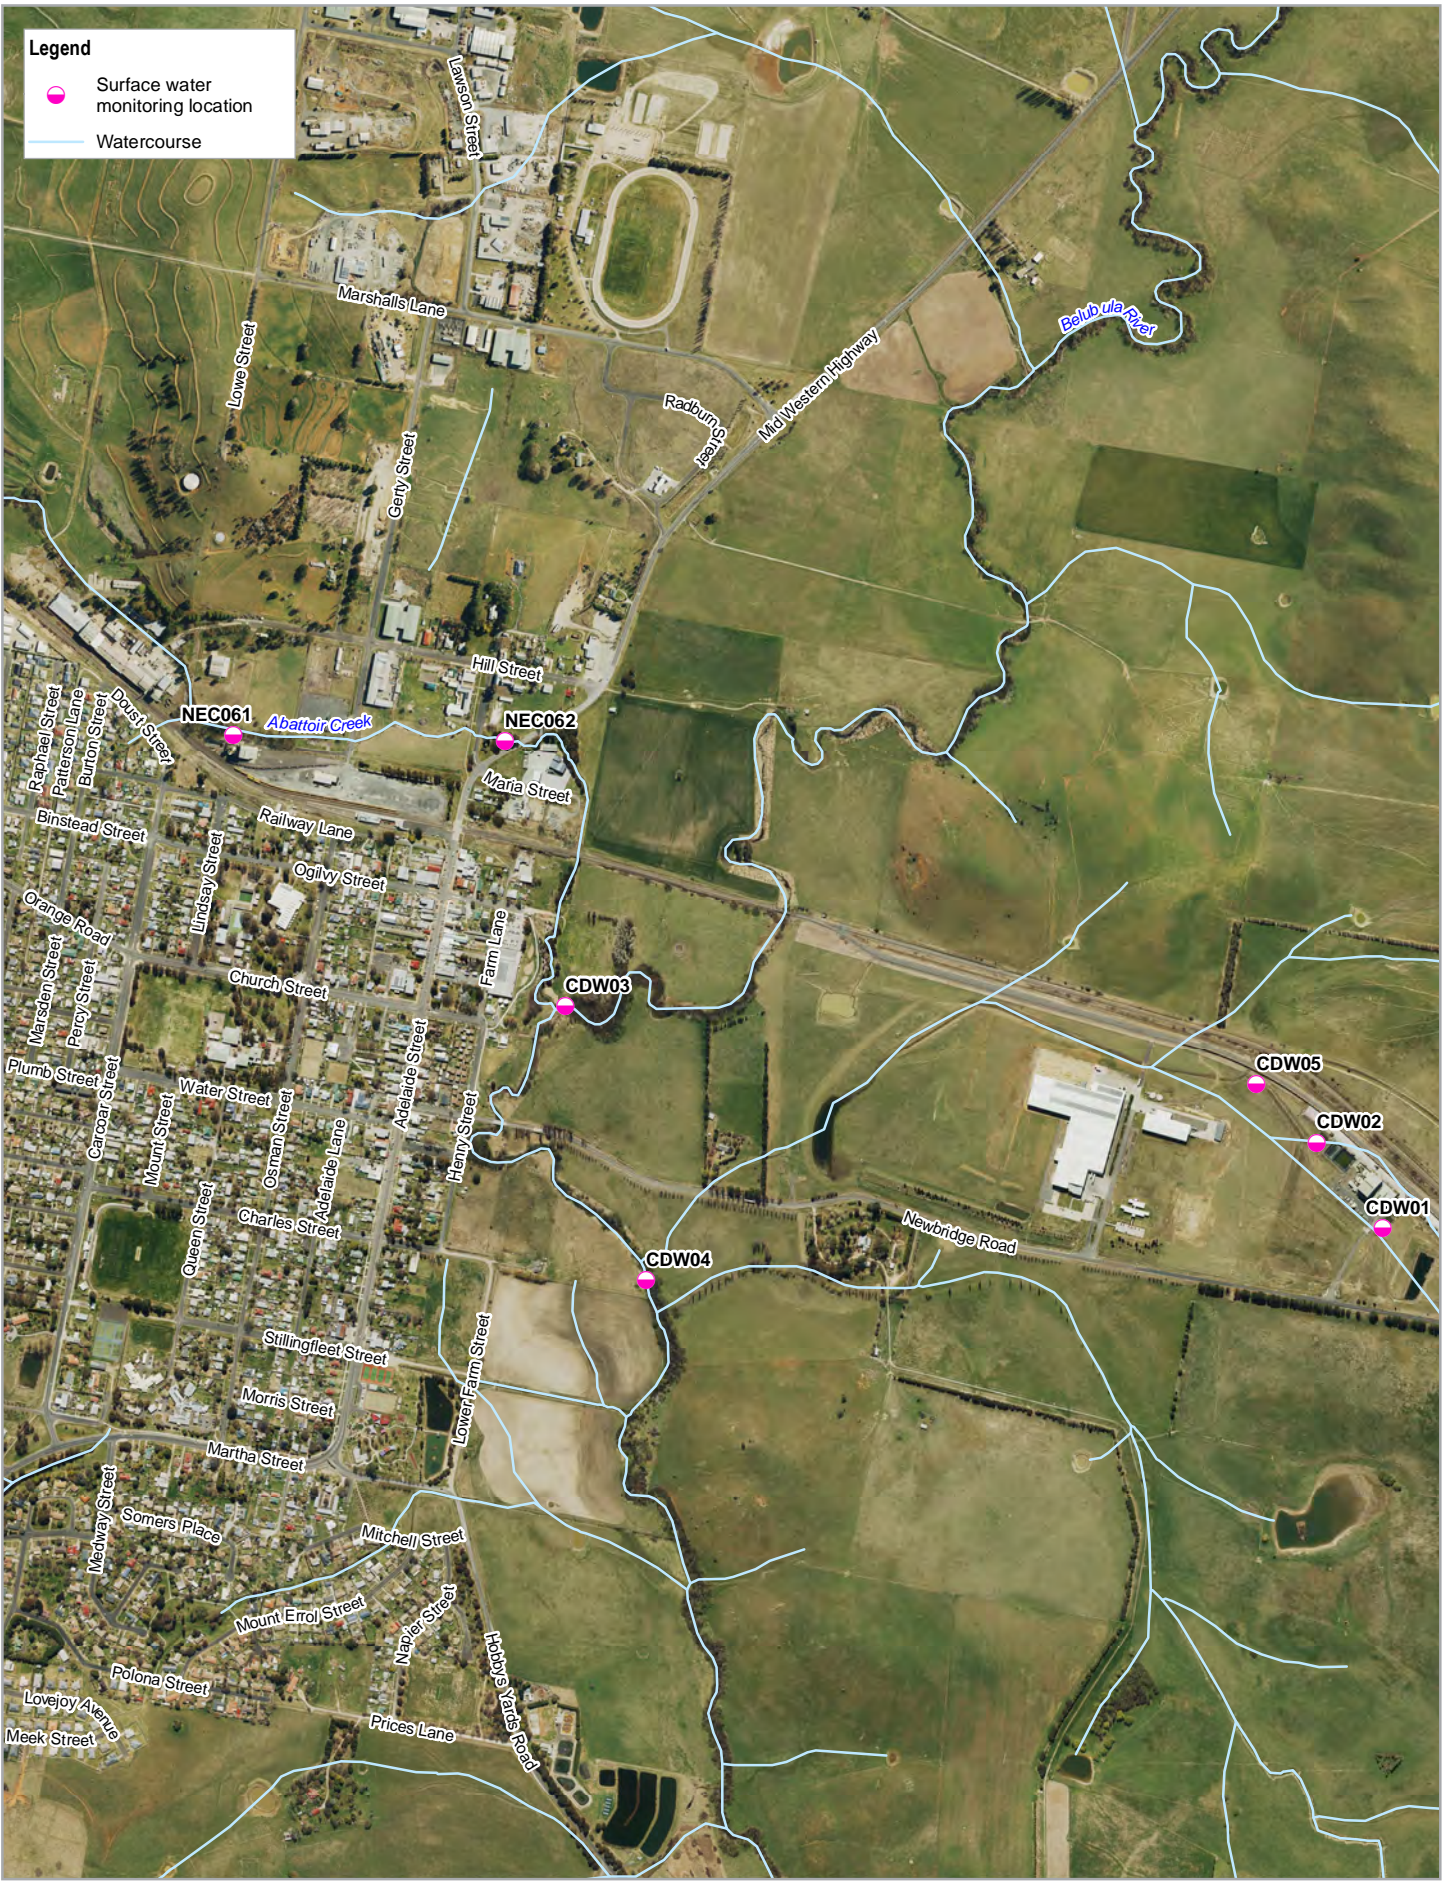
The Blayney Dewatering Facility was demolished between March and April 2020. Remediation works followed the site's decommissioning, and the site has now been relinquished to its owner. Monitoring sites at the dewatering facilities are shown in Figure 3.33.

Surface water is monitored at NEC061 and NEC062 in the Blayney Dewatering Facility (BDF) area. The location of these sites is shown in Figure 3.33.

Surface water is monitored at CDW01, CDW02, CDW03, CDW04 and CDW05 in the Cadia Dewatering Facility (CDF) area. These sites are all potential impact sites as they can be influenced by site operations. CDF monitoring sites are shown in Figure 3.33.
