CADIA

710-005-EN-PLA-0026

REHABILITATION MANAGEMENT PLAN

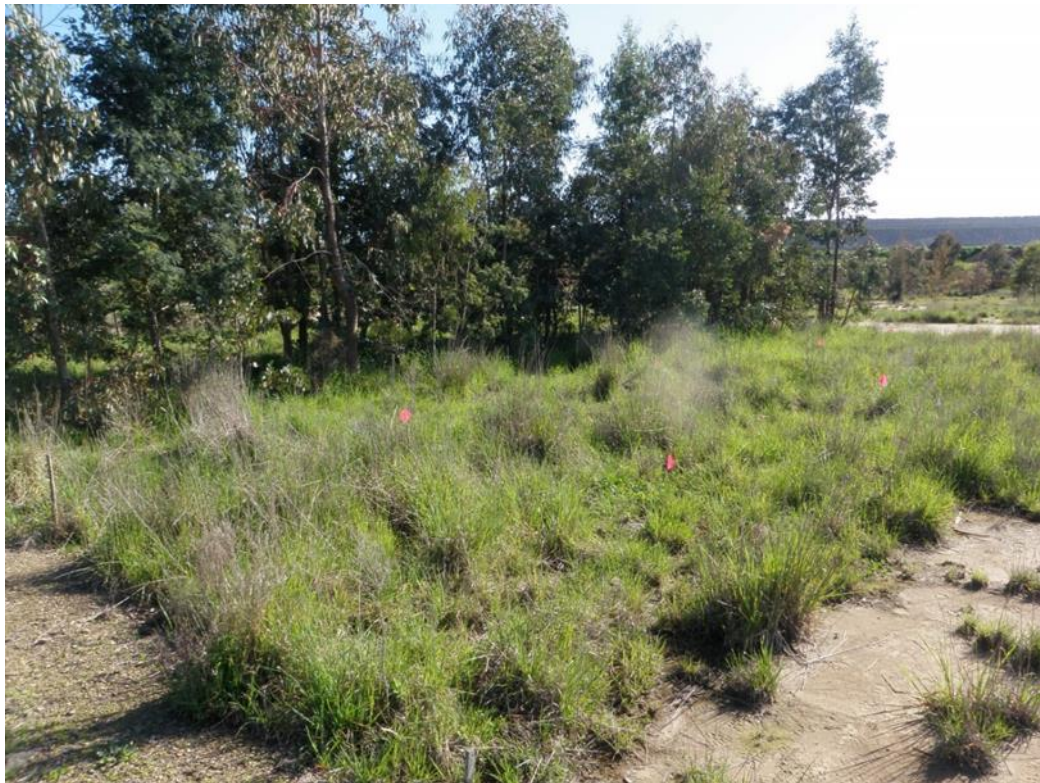
Figure 1. Tailings Revegetation Trial

- Vegetation persisted and grew for the entirety of the trial, through severe drought conditions and demonstrated seeding, recruitment and sustained growth (Figure 1).

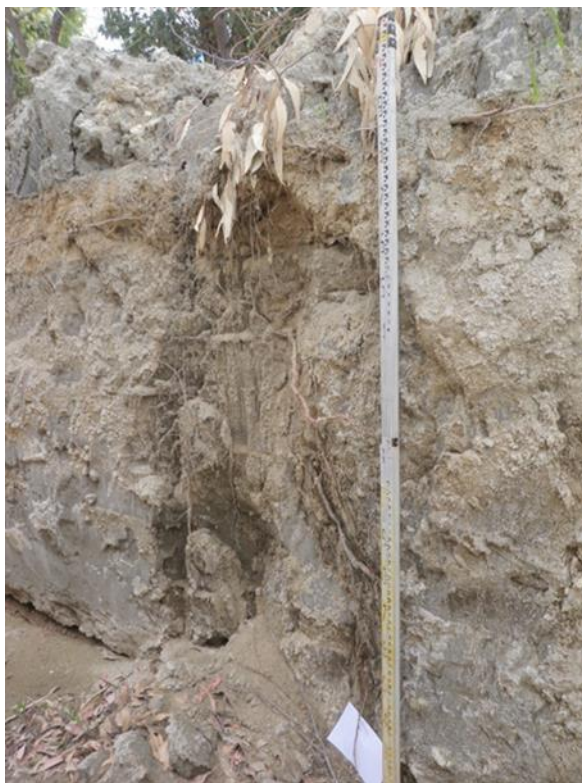
Figure 2. Tailings Revegetation Trial – Root Penetration

- There was no lateral capping of roots. Roots from trees, shrubs and grasses penetrated well into the tailings, beyond 2.5m depth for woodland species (Figure 2).
